# The Bangudae Petroglyph in Ulsan, Korea: studies on weathering damage and risk prognosis

B. Fitzner · K. Heinrichs · D. La Bouchardiere

**Abstract** The prehistoric Bangudae Petroglyph in the Ulsan area represents an outstanding National Treasure of the Republic of Korea. Since the construction of the Sayeon dam, the petroglyph with about two hundred carvings is periodically submerged by the Sayeon reservoir. The danger of increasing damage has resulted in intensive efforts to protect this cultural heritage. Diagnosis and risk prognosis studies were carried out. Results of petrographical studies, monument mapping and in situ measurements are presented. Types, degree and zonation of damage are evaluated. The risk estimation derived from the studies confirms the necessity of preservation measures.

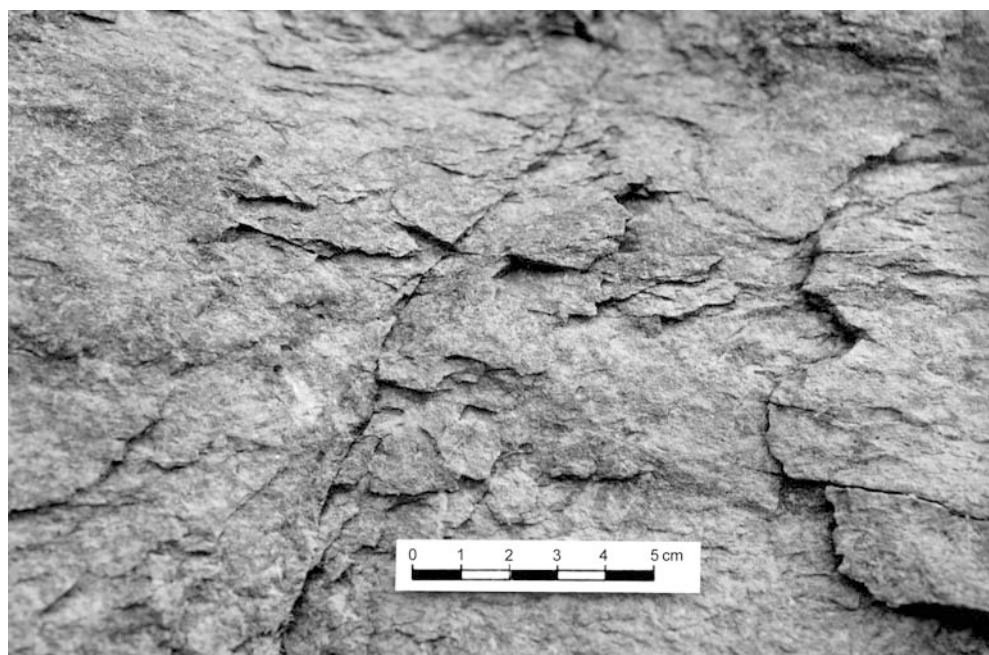
**Fig. 11**  
Weathering form “multiple  
flakes to crumbling (mF-Pu)”

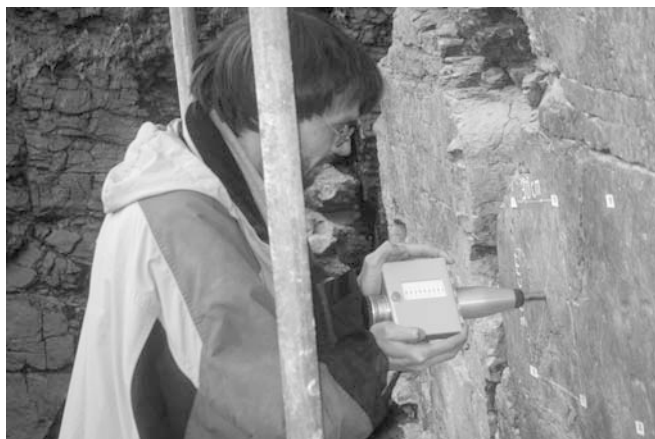
**Fig. 19**

Rebound hardness measurements with a Schmidt hammer

The rebound hardness measuring procedure is illustrated in Fig. 19 and the distribution of the rebound hardnesses is classified in Fig. 20. The registered rebound hardnesses range between 19 and 56. The rebound hardness for non-carved areas without any detachment of stone material ranges between 45 and 56 (average: 49). It is striking that the rebound hardness for carved areas without any visible stone deterioration is considerably lower. It ranges between 34 and 46 (average: 41). This indicates a weakening of the grain-bond due to the carving procedure. With respect to detachment of stone material, the lowest rebound hardnesses were stated for stone surfaces affected by intense crumbly disintegration. Considering the rather high average rebound hardnesses related to other types of detachment of stone material, it can be deduced that the detaching stone pieces are still well-connected to the stone beneath. Therefore, a rapid loss of stone material in the near future is not very probable. Results obtained from the evaluation of weathering forms and from the in situ measurements (ultrasonic measurements, rebound hardness measurements) were combined for the characterization and quantification of damage zones.
