Stone monuments of the Nemrud Dag sanctuary/Turkey – petrographical investigation and diagnosis of weathering damage

Kurt Heinrichs & Bernd Fitzner*

Heinrichs, K. & Fitzner, B. (2007): Stone monuments of the Nemrud Dag sanctuary/Turkey – petrographical investigation and diagnosis of weathering damage. [Steinmonumente des Nemrud Dag Heiligtums/Türkei – petrographische Untersuchung und Diagnose der Verwitterungsschäden.] – Z. dt. Ges. Geowiss., 158: 519–548 Stuttgart.

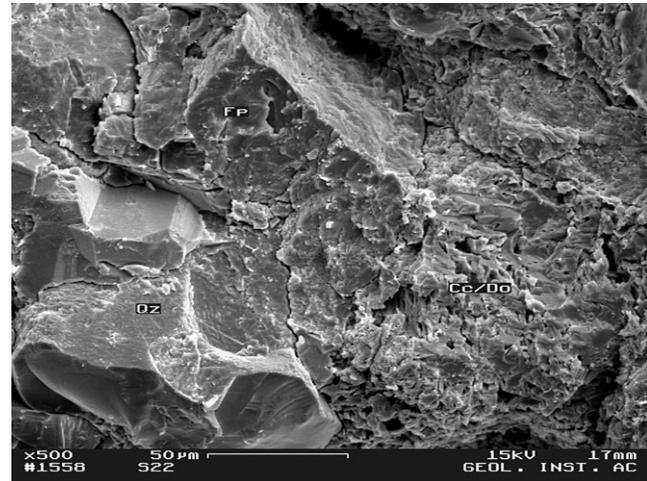
Fig. 6: Mineral composition – sandstone. SEM-micrograph, image width: ~ 0.23 mm. Qz = quartz, Fp = feldspar, Cc = calcite, Do = dolomite.

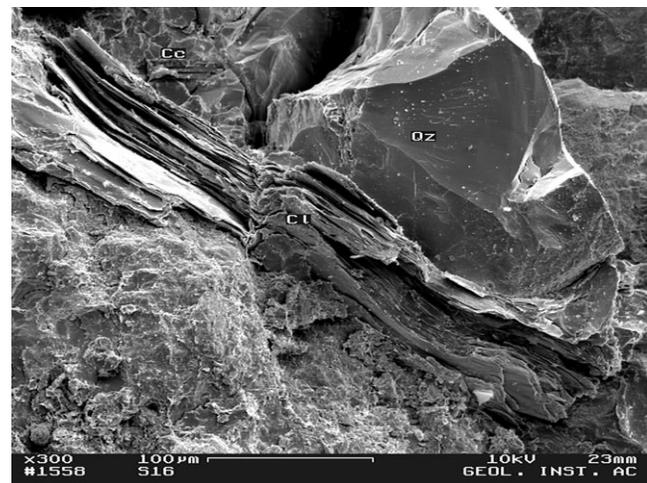
Fig. 7: Mineral composition – sandstone. SEM-micrograph, image width: ~ 0.39 mm. Qz = quartz, Cc = calcite, Cl = chlorite.

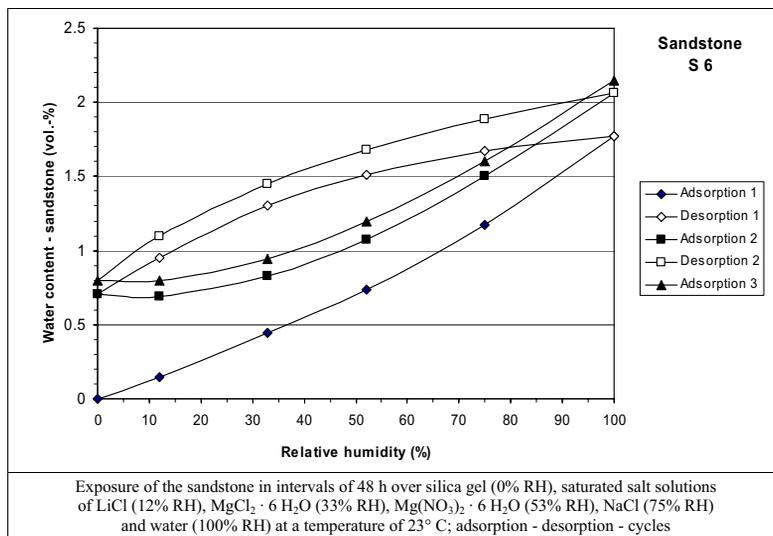
Fig. 8: Isothermal adsorption of air humidity (Sandstone S 6).

adsorption of air humidity was measured. Results are presented in figure 8 for the sandstone with S 6 as an example. The adsorption of air humidity is decisively controlled by the portion of micropores and the process of capillary condensation. It was found that the water content of the sandstones – expressed in vol.-% – in the adsorption/desorption cycle test at a temperature of 23 °C approximates to the volume of their micropores at the end of the adsorption phases. Longer exposure of the sandstones at continuously 100 % RH/23 °C results in further increase of water content in the sandstones (additional water content between 0.8 and 1.3 vol.-%, partial filling of capillary pores). This means that the sandstones of Nemrud Dag can be considered as “wet” when exposed over a long period at high air humidity.

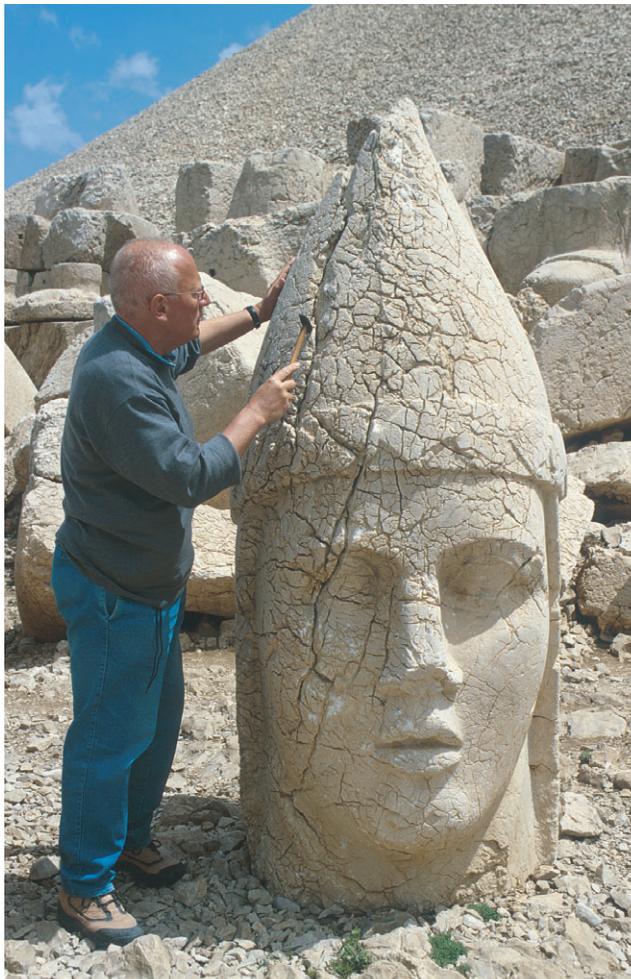
The main weathering phenomena observed on the limestone statues are a loss of compact stone fragments, cracks and especially microkarst (Figs. 9, 10). Microscope studies (transmitted light microscopy, scanning electron microscopy) have shown that microkarstification often originates from physical disintegration of the coarsely sparitic veins in the limestones resulting in an

Fig. 9: Head of Apollo – west terrace, limestone. Loss of stone fragments, cracks, and microkarst.

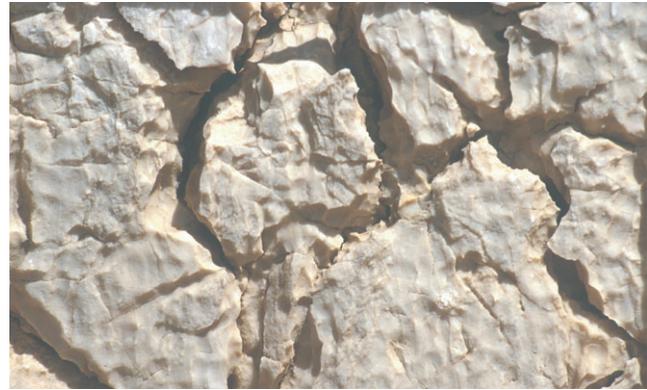
Fig. 10: Microkarst – limestone statue. Width of the section: 24 cm.

increase in porosity (Fig. 11). This intensifies water penetration and related dissolution processes. The microkarst forms extend in width and depth over the time. Microkarst profile measurements at the limestone statues with profile combs have shown depths of karstification up to 3 cm (Figs. 12, 13). In the worst cases microkarstification results in fragmental disintegration of the limestones (breaking up of the limestone into pieces of variable dimension and irregular shape). Often, microbiological colonization (e.g. lichen) can be observed on the limestones.

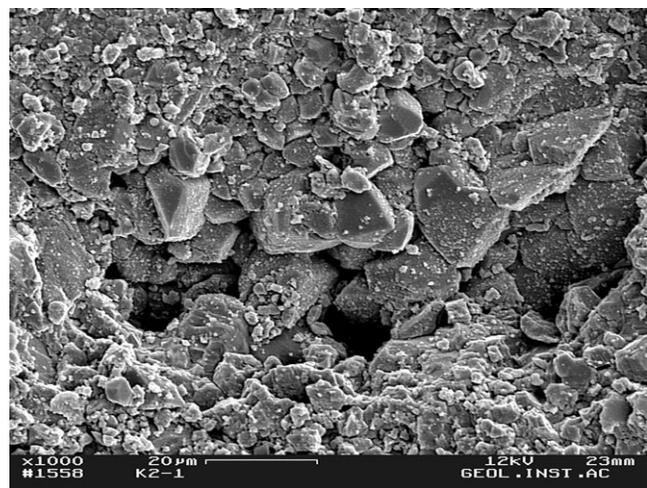
Fig. 11: Weathering of coarsely sparitic veins in the limestone resulting in increase of porosity. SEM-micrograph, image width: ~ 0.12 mm.

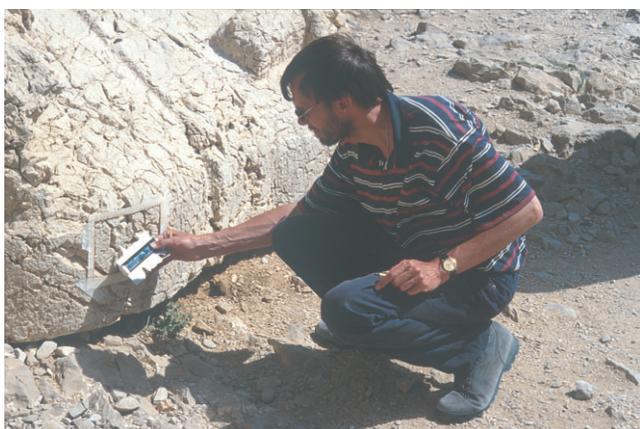
Fig. 12: Profile measurements – limestone statues.

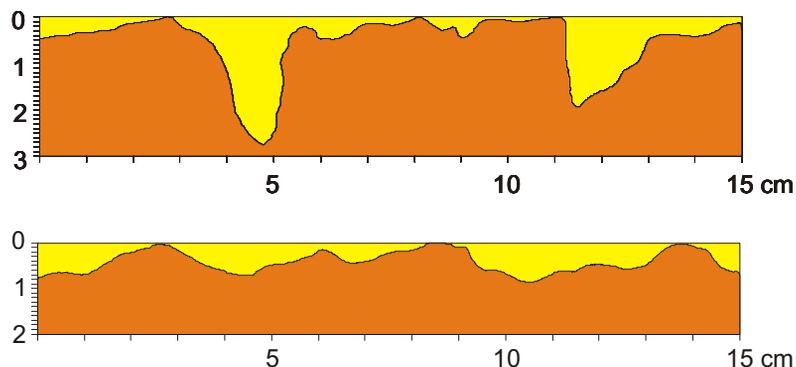
Fig. 13: Microkarst profiles – limestone statues.

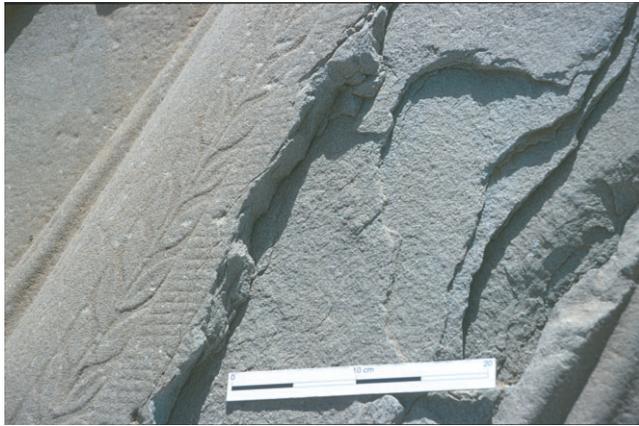
Fig. 14: Weathering form “exfoliation”. Xerxes I stele – west terrace, sandstone.

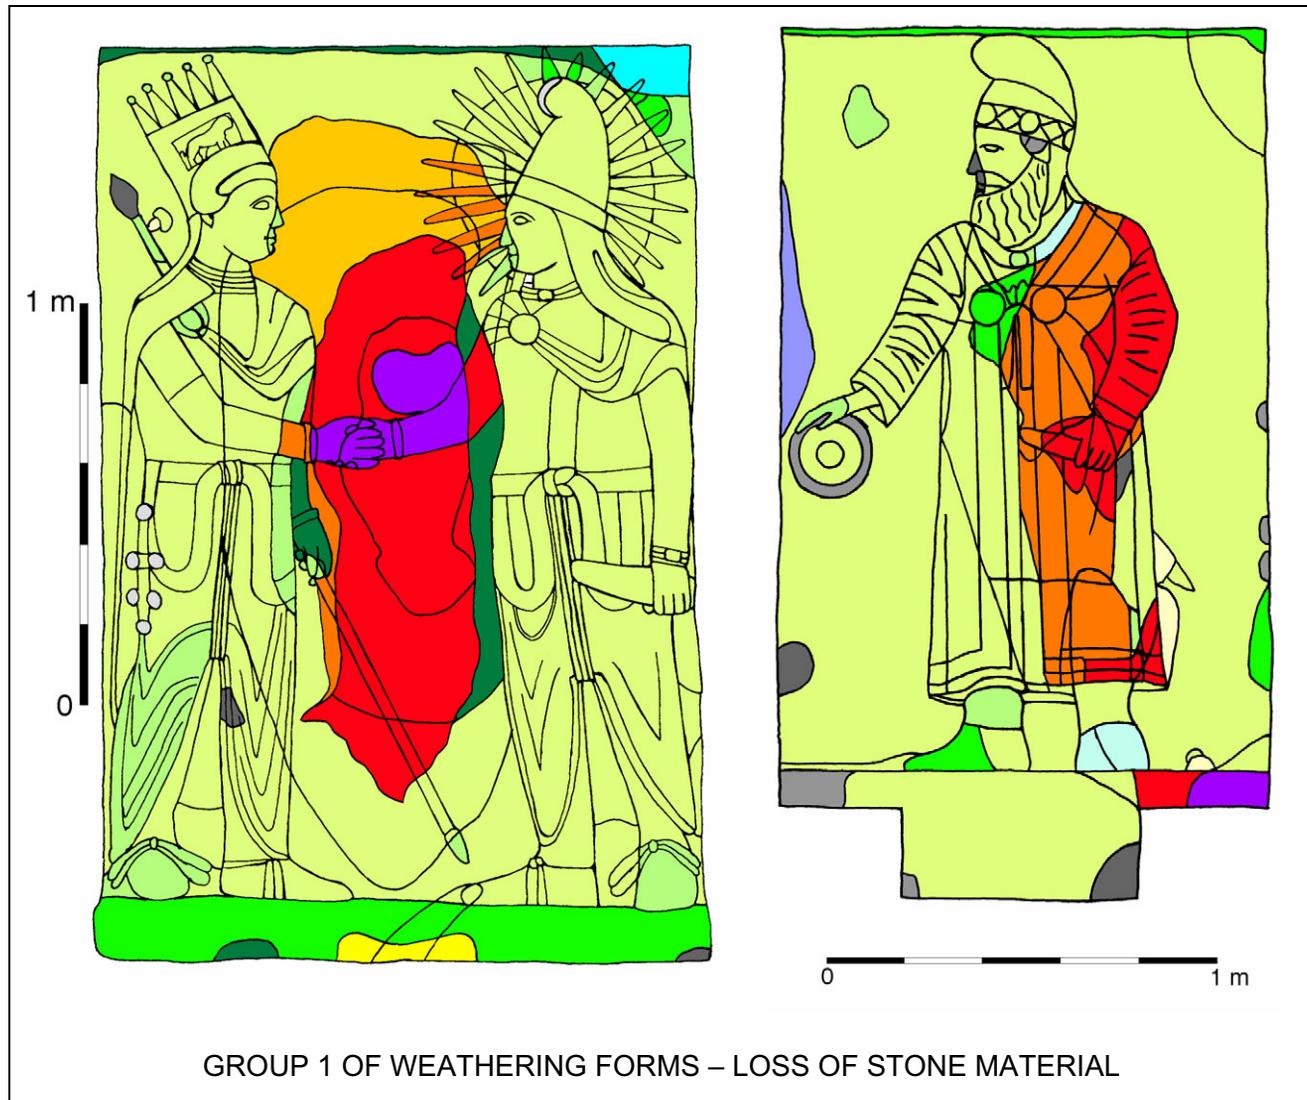
With respect to loss of stone material (group 1 of weathering forms), most of the stele is affected by rounding/notching (Fig. 18). Rounding/notching is mainly of intensity 1 (depth of relief: 0.2 cm). The most striking loss of stone material is through back weathering due to exfoliation. It affects the central part of the stele between the reliefs of the King and Apollo. Back weathering occurs with different intensities up to intensity 6 (depth of back weathering: 5–10 cm). Intensity 4 (depth of back weathering: 1–3 cm) is prevailing. Break out due to natural causes affects corners/edges of the stele and smaller parts of the relief, especially parts of the relief of the King. Most striking break out (intensity 5, volume of break out: 250–1000 cm³) concerns the upper right corner of the stele. Loss of stone material did not increase between 1988 and 2002.

In terms of the loss of stone material, most of the stele is affected by rounding/notching (Fig. 18). Intensity 1 of

this weathering form is most prevalent (depth of relief: 0.2 cm). The most significant weathering form characteristic of the loss of stone material is back weathering due to exfoliation. It affects especially the right part of the Xerxes I relief with intensities 4 and 5 (depth of back weathering: 1–3 cm, resp. 3–5 cm). From 1988 to 2002 back weathering due to exfoliation has slightly increased. Break out due to natural causes affects corners/edges of the stele and parts of the relief. The most striking break out (intensity 6, volume of break out: 1000–5000 cm³) is seen on the left edge of the stele.

Fig. 18: Map of the weathering forms of group 1 – loss of stone material (2002). Apollo dexiosis stele (left) and Xerxes I stele (right) – west terrace, sandstone.

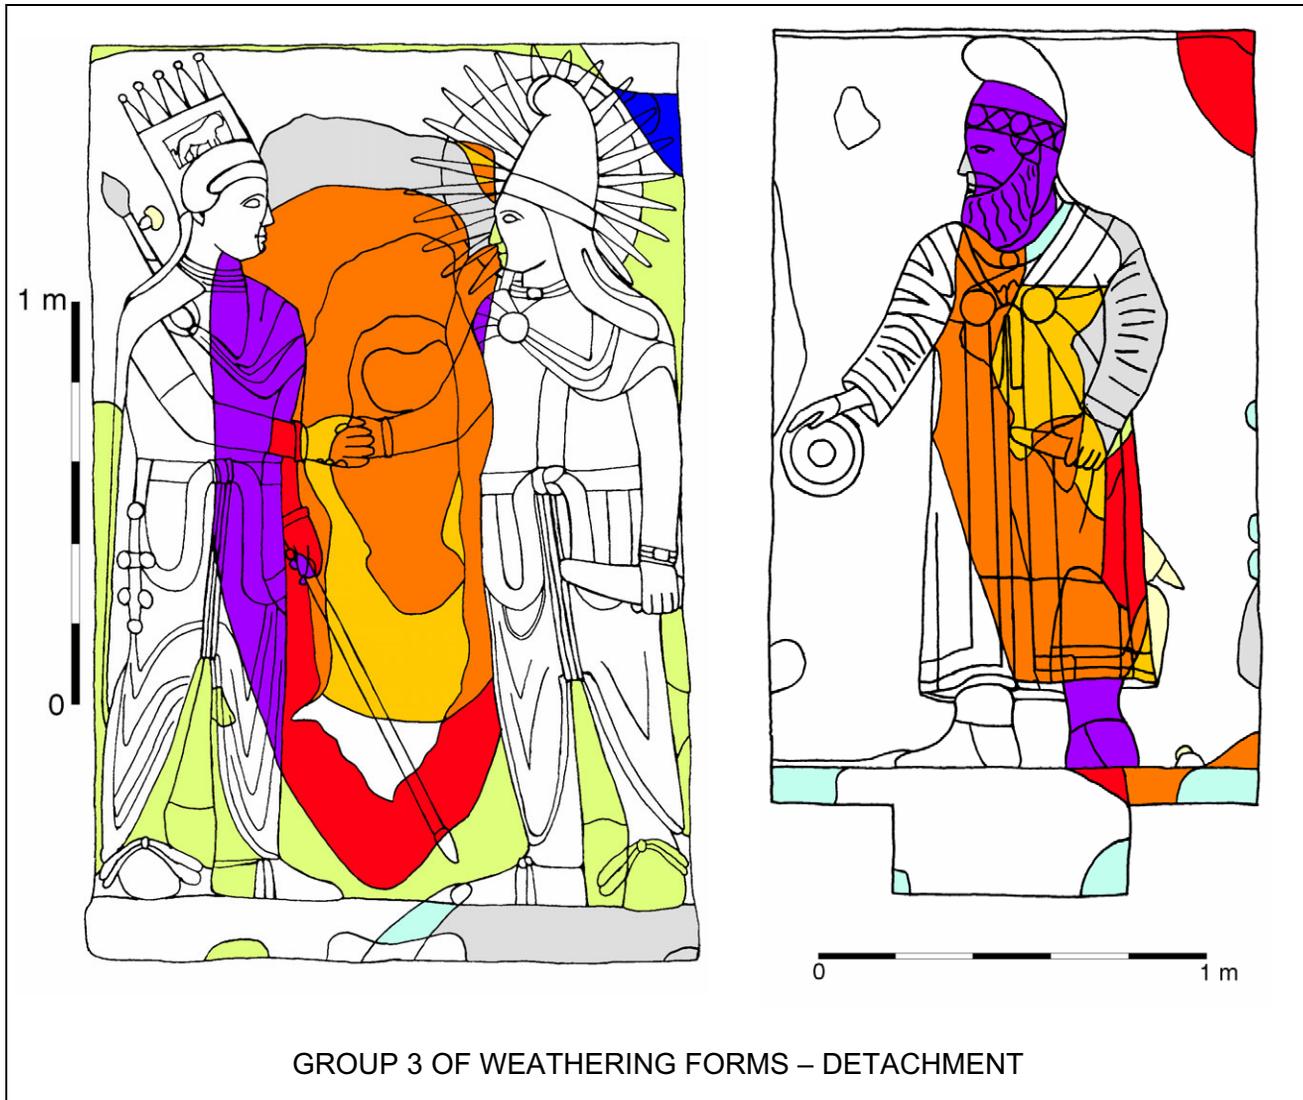
With respect to detachment (group 3 of weathering forms), exfoliation represents the most prevalent and most significant weathering form (Fig. 19). Exfoliation occurs with different intensities up to intensity 6 (thickness of the detaching layer/stack of layers: 5–10 cm). Intensity 4 (thickness of the detaching layer/stack of layers: 1–3 cm) is prevailing. Exfoliation mainly affects the central part of the stele and the right part of the relief of the King. Different phases of exfoliation have taken place over the time. Comparing the maps from 1988 and 2002, exfoliation of intensity 6 is seen to have extended in the direction of the left relief (the King). Granular disintegration, crumbling and their transitional form represent additional weathering forms characterizing the detachment of stone material. They are mainly of intensity 1 (mass of detaching stone material: low).

With respect to detachment, exfoliation is the most prevalent and most significant weathering form (Fig. 19). Exfoliation occurs with different intensities up to intensity 6 (thickness of the detaching layer/stack of layers: 5–10 cm), although intensity 4 (thickness of the detaching layer/stack of layers: 1–3 cm) predominates. Exfoliation mainly affects the Xerxes I relief. Comparing the maps from 1988 and 2002, it is found that exfoliation of intensity 6 has extended to the head of the Xerxes I relief. Granular disintegration, crumbling, and their transitional form occur as additional weathering forms characterizing detachment of stone material. They are only of intensity 1 (mass of detaching stone material: low) and they mainly concern edges/corners of the stele.

Fig. 19: Map of the weathering forms of group 3 – detachment (2002). Apollo dexiosis stele (left) and Xerxes I stele (right) – west terrace, sandstone.

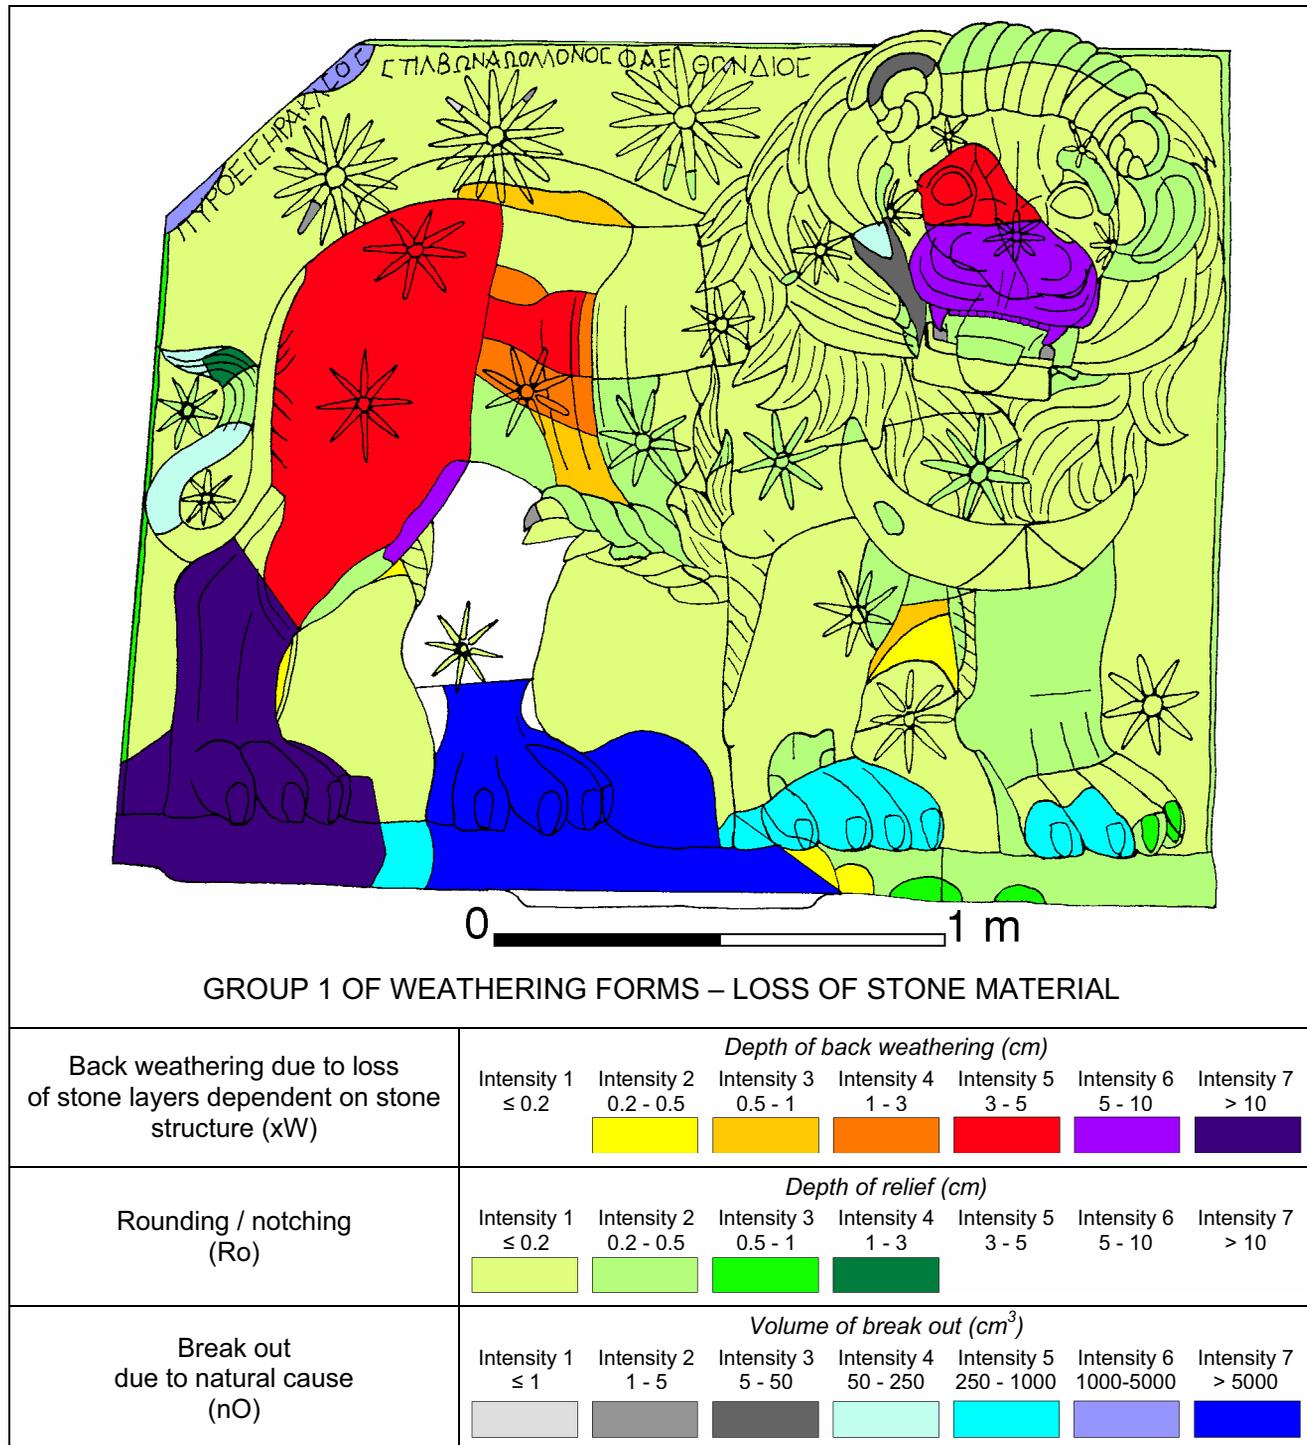
due to exfoliation. It affects large parts of the lion relief. Back weathering occurs with different intensities. Intensities 5–7 (depth of back weathering: 3–5 cm, 5–10 cm, > 10 cm) are prevailing. From 1988 to 2002 back weathering due to exfoliation has significantly increased, especially concerning the left part of the lion relief. Break out due to natural causes concerns corners / edges of the stele and parts of the relief (especially claws of the lion, intensities 5 and 7 – volume of break out: 250–1000 cm³, resp. > 5000 cm³). One larger part of the lion relief has broken off in the period between 1988 and 2002.

Fig. 20: Map of the weathering forms of group 1 – loss of stone material (2002). Lion Horoscope – west terrace, sandstone.

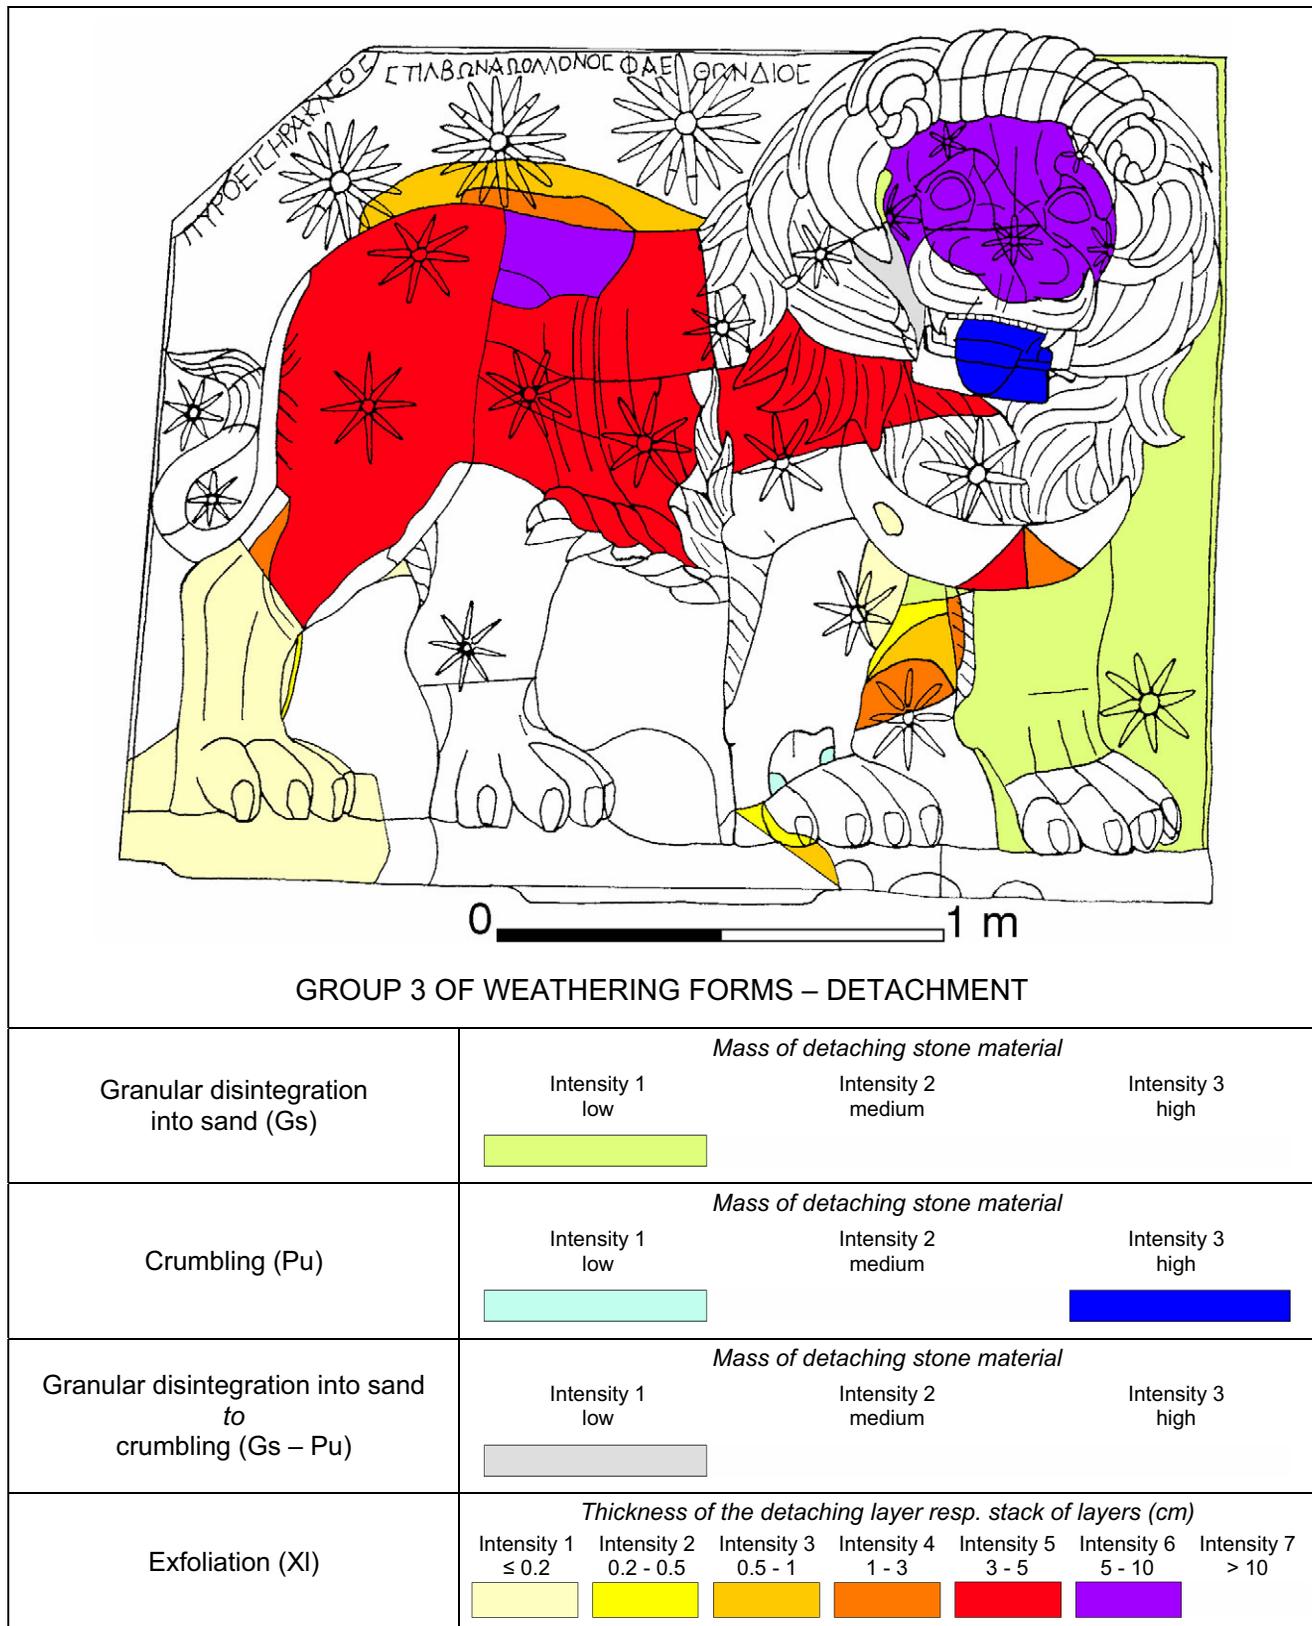
Regarding detachment of stone material, exfoliation is the most prevalent and most significant weathering form (Fig. 21). Exfoliation occurs with different intensities up to intensity 7 (thickness of the detaching layer/stack of layers: > 10 cm). Intensity 5 (thickness of the detaching layer/stack of layers: 3–5 cm) predominates. Exfoliation mainly affects the relief of the lion. Comparing the maps from 1988 and 2002, it is found that exfoliation has slightly extended over the surface of the relief. However, owing to back weathering due to exfoliation over the last years, intensity of exfoliation is partly reduced (secondary generations of exfoliation with lower thickness of detaching layers/stack of layers). Granular disintegration, crumbling and their transitional form occur as additional weathering forms characterizing detachment of stone material. They are mainly of intensity 1 (mass of detaching stone material: low).

Fig. 21: Map of the weathering forms of group 3 – detachment (2002). Lion Horoscope – west terrace, sandstone.

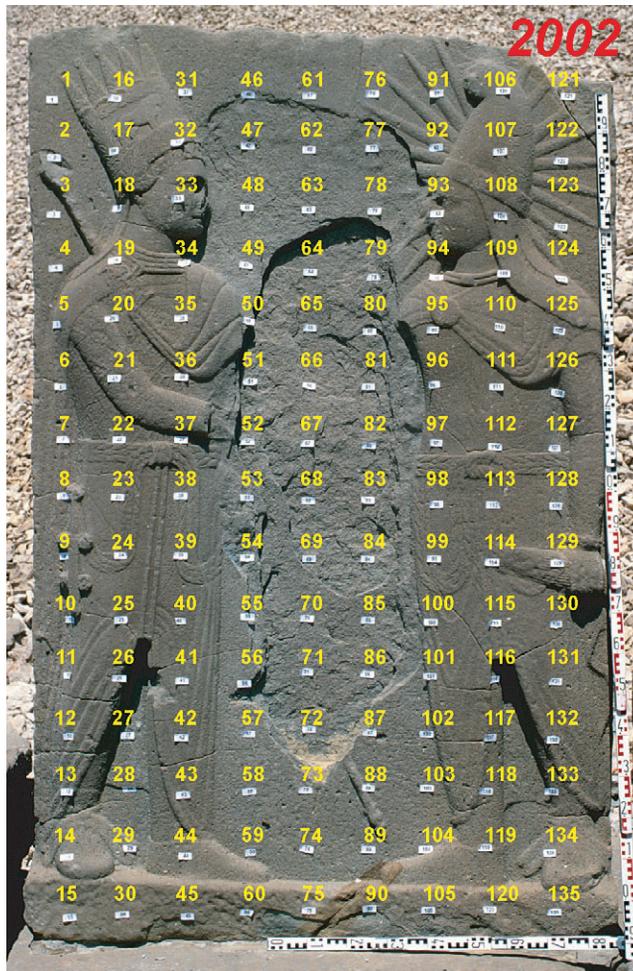
Ultrasonic measurements represent a suitable non-destructive method for information on the state of weathering. Ultrasonic measurements were carried out at the Apollo dexiosis stele and the Lion Horoscope of the west terrace. Grids of measuring points were arranged on the front side of the stelae (Figs. 22, 23) and then were transferred to their rear side. The distances between corresponding measuring points were determined. Ultrasonic measurements were made according to transmission mode. The ultrasonic velocities were calculated from transit time and measured distance. They were illustrated in maps, based on isoline calculations.

Fig. 22: Grid of measuring points for ultrasonic measurements. Apollo dexiosis stele – west terrace, sandstone.

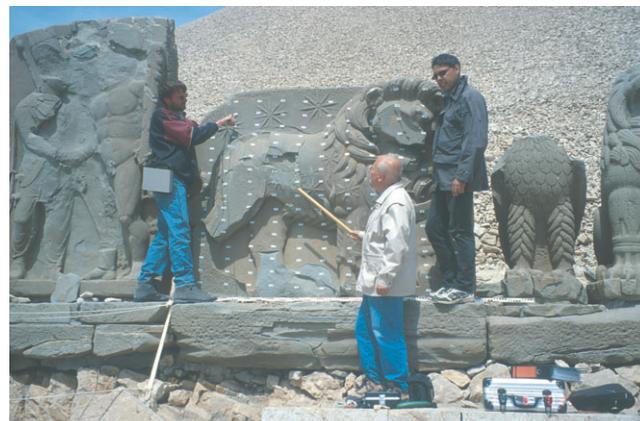
Fig. 23: Ultrasonic measurements. Lion Horoscope – west terrace, sandstone.

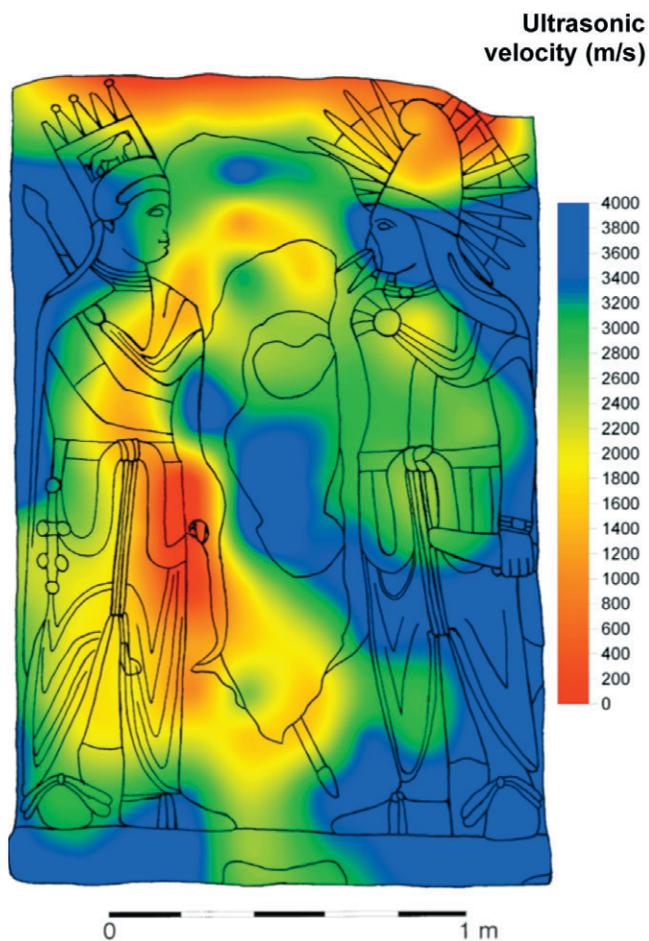
The maps of ultrasonic velocities for the Apollo dexiosis stele and the Lion Horoscope are presented in figures 24 and 25. Decreasing ultrasonic velocities (indicated by colour change from blue via green and yellow to red) correspond to increasing physical disintegration of the sandstone (granular or crumbly disintegration, exfoliation). Very low ultrasonic velocities mainly correspond with exfoliation of the sandstone. Comparing the maps of ul-

trasonic velocities with maps of weathering forms characteristic of the detachment of stone material, the presence of considerable non-visible disintegration and detachment of stone material can be additionally identified, especially in the case of the Lion Horoscope.

Fig. 24: Map of ultrasonic velocities (2002). Apollo dexiosis stele – west terrace, sandstone.

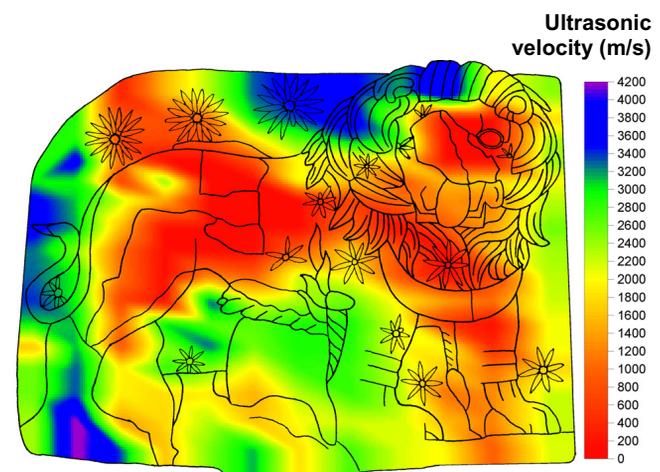
The results gathered from the ultrasonic measurements attest alarming extent of weathering damage, too. They reveal higher extent of damage for the Lion Horoscope (reduction of ultrasonic velocities: ~ 55 % on average) in comparison with the Apollo dexiosis stele (reduction of ultrasonic velocities: ~ 30 % on average). This confirms the ranking derived from evaluation of damage indices. The results in all indicate the need of monument preservation measures.

Fig. 25: Map of ultrasonic velocities (2002). Lion Horoscope – west terrace, sandstone.

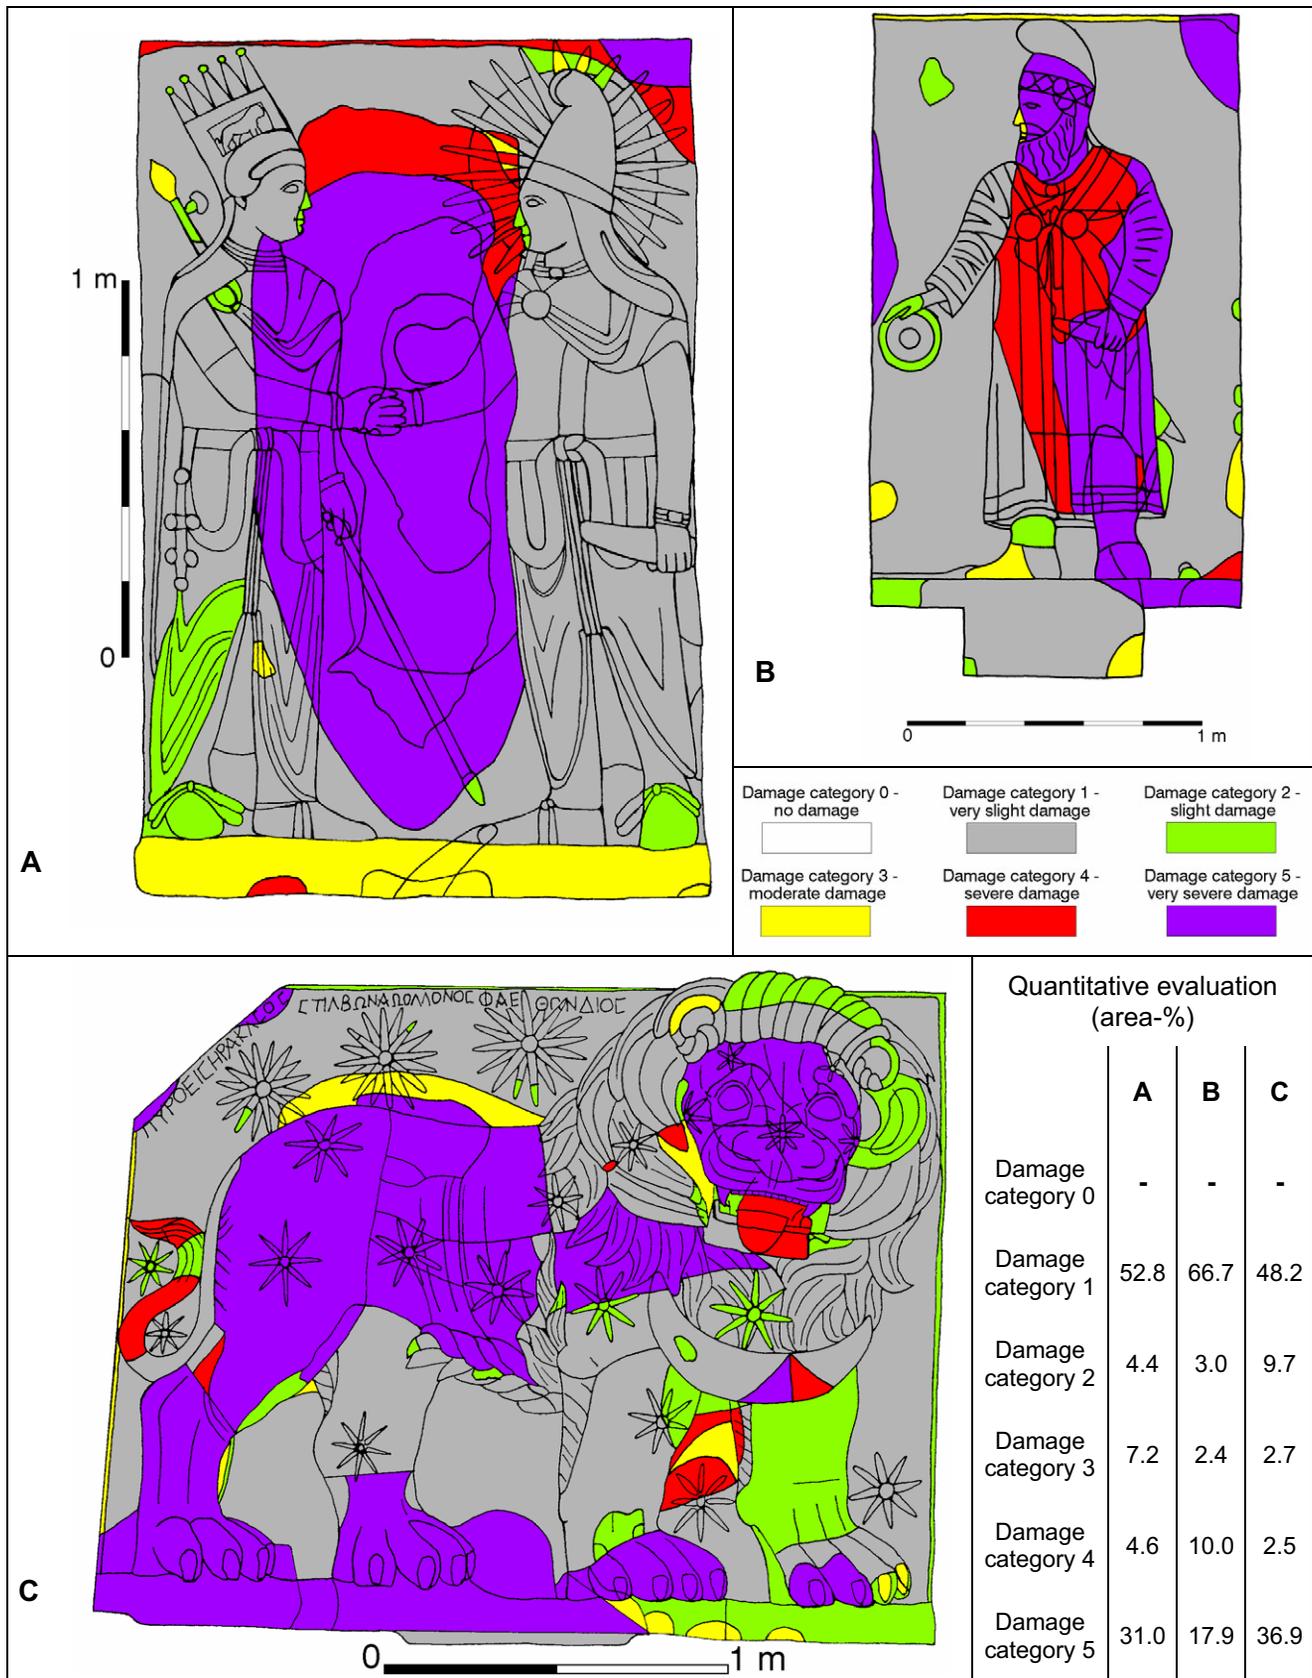
In figure 28 the maps of final damage categories with quantitative evaluation are presented for the front faces of Apollo dexiosis stele, Xerxes I stele, and Lion Horoscope. They relate to the year 2002. The surfaces of all stelae are entirely affected by damage. Very slight damage is prevailing (Apollo dexiosis stele: 53 %, Xerxes I stele: 67 %, Lion Horoscope: 48 %). However, the very high portion of severe to very severe damage is most alarming (Apollo dexiosis stele: 36 %, Xerxes I stele: 28 %, Lion Horoscope: 39 %). Comparing the three stelae, the overall extent of damage increases from Xerxes I stele via Apollo dexiosis stele to Lion Horoscope (Xerxes

I stele: $DI_{lin} = 2.09$, $DI_{prog} = 2.66$, Apollo dexiosis stele: $DI_{lin} = 2.57$, $DI_{prog} = 3.14$, Lion Horoscope: $DI_{lin} = 2.70$, $DI_{prog} = 3.28$). When comparing Xerxes I stele and Apollo dexiosis stele, it should be considered that very severe damage on the Xerxes I stele affects parts of the relief to higher extent than on the Apollo dexiosis stele.

Fig. 28: Maps of final damage categories with quantitative evaluation (2002). A = Apollo dexiosis stele, B = Xerxes I stele, C = Lion Horoscope. West terrace, sandstone.

The results of the diagnostical studies in all indicate the need of interventions for monument preservation. They enhance the planning and implementation of appropriate monument preservation measures. This concerns immediate safeguarding measures, measures for the reduction of causes of damage, measures for remedy of damage and preventive measures. The following types of preservation measures should be taken into consideration: re-erection/re-arrangement, protection of the monuments against further loss of stone material (e.g. fixation of detaching stone

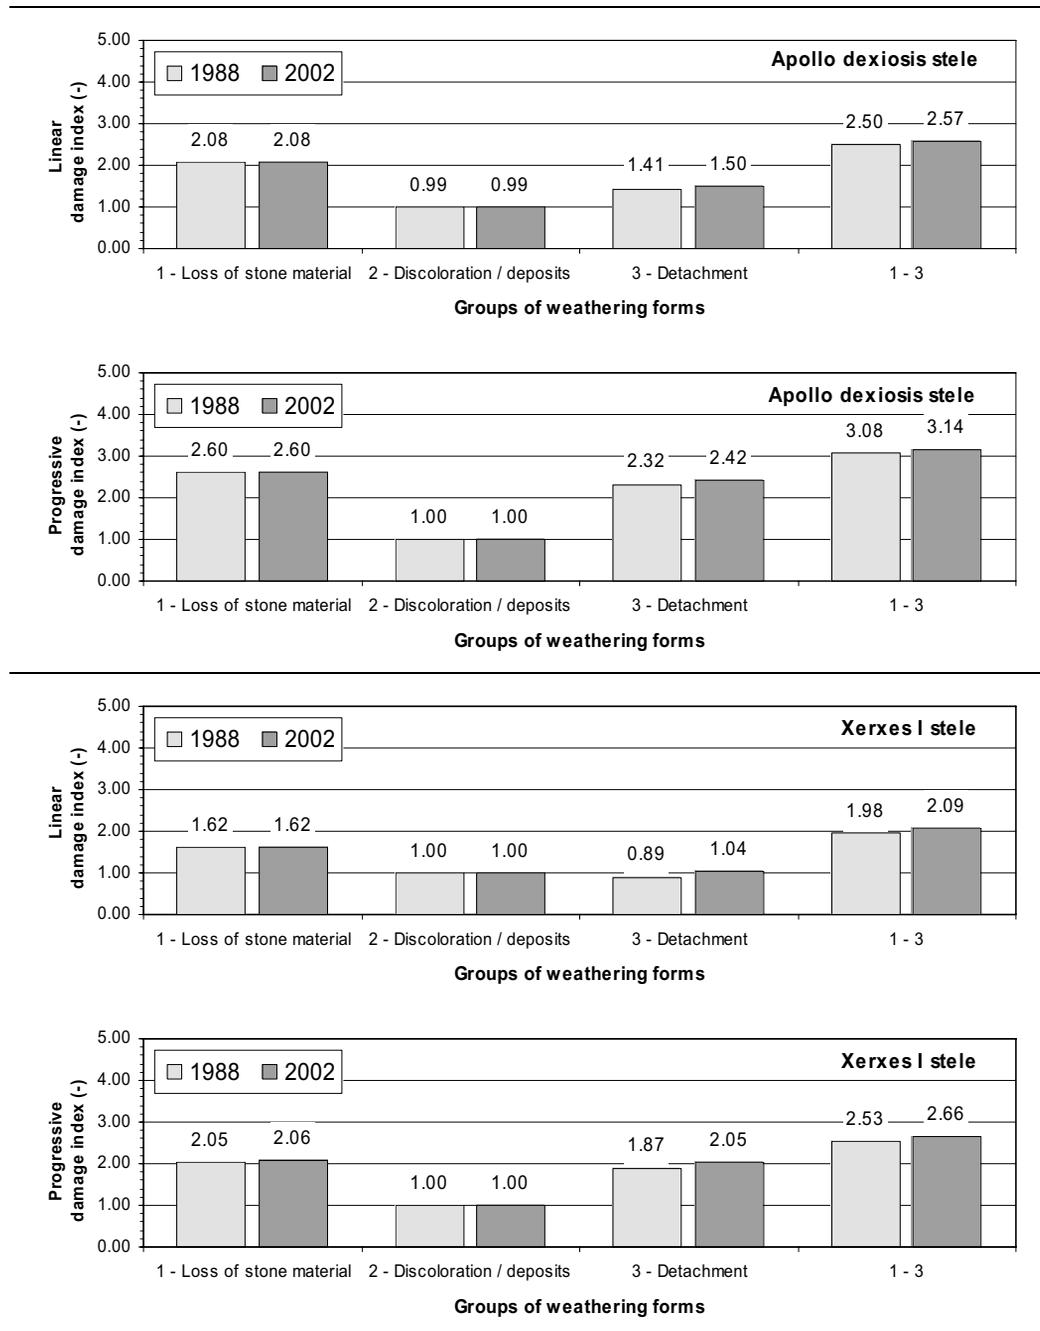
Fig. 29: Comparison of linear and progressive damage indices in 1988 and 2002. Apollo dexiosis stele and Xerxes I stele – west terrace, sandstone.

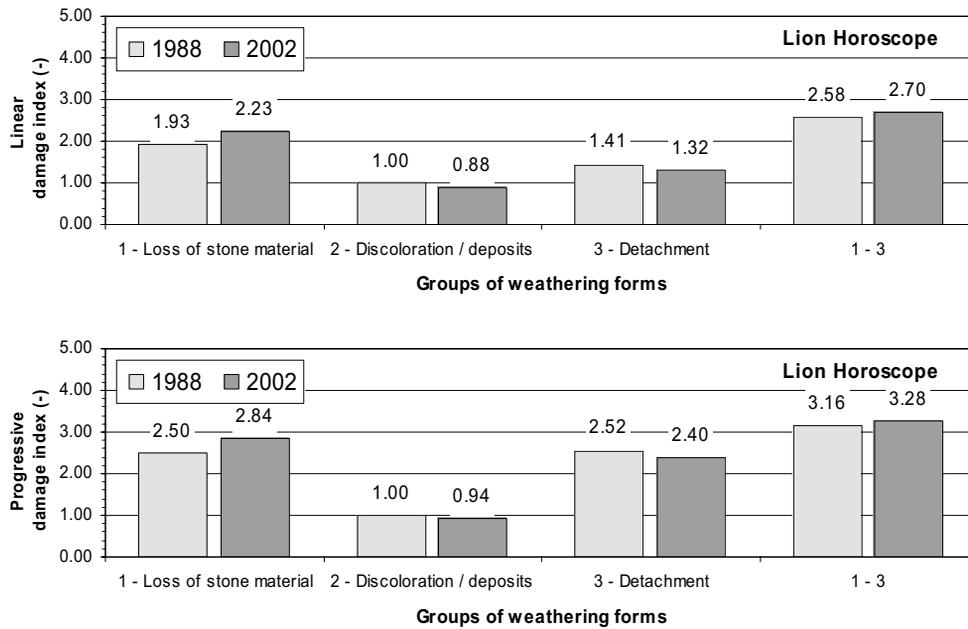
Fig. 30: Comparison of linear and progressive damage indices in 1988 and 2002. Lion Horoscope – west terrace, sandstone.

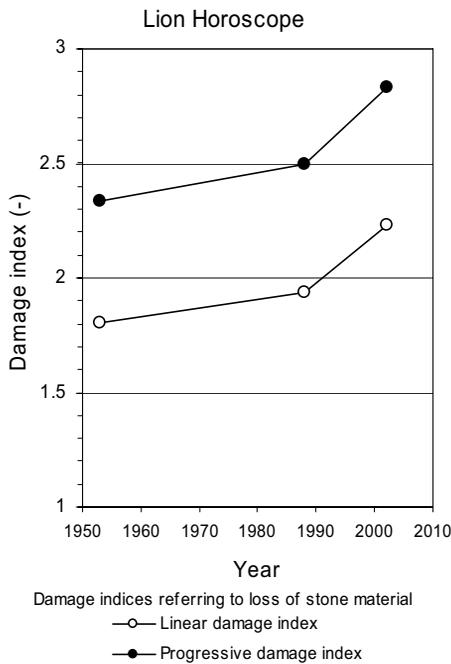
For further assessment of weathering progression, a photograph of the Lion Horoscope from 1953 (in Sanders 1996), a photograph of the Xerxes I stele from 1956 (Sanders 1996) and a photograph of a gypsum replica of the Xerxes I stele made in 1883 (Dörner 1987) were considered as references. The photos were evaluated with respect to loss of stone material (weathering forms – damage categories – damage indices). This has allowed comparison of the loss of stone material over a period of 49 years for the Lion Horoscope (1953–2002) and 119 years for the Xerxes I stele (1883–2002). The results are presented in figures 31 and 32. The graphs show the alarming increase of damage over the last century. The fact that there was no further loss of stone material on the Xerxes I stele between 1988 and 2002 should not be misinterpreted in this regard. Detachment of stone material has extended in that period and this will result in further loss of stone material, probably in near future.

Fig. 31: Weathering progression. Lion Horoscope – west terrace, sandstone.

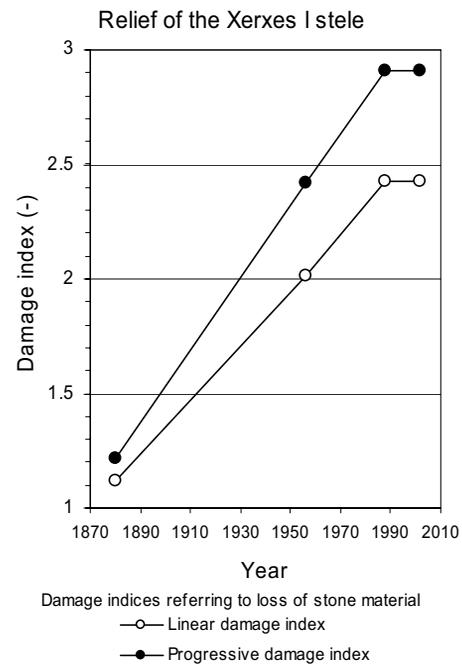
Fig. 32: Weathering progression. Relief of the Xerxes I stele – west terrace, sandstone.
