# Stone properties and weathering induced by salt crystallization of Maltese Globigerina Limestone

**Abstract:** Most monuments and buildings in the Maltese Islands are constructed of the local Globigerina Limestone. Today, this Globigerina Limestone shows considerable damage in many buildings, particularly through alveolar weathering, which is frequently very intense. Owing to Malta's marine environment, salt crystallization in the stone's pore spaces has been recognized as the main weathering process responsible for the deterioration of the country's monuments. In order to obtain more information on the fabric-dependent weathering processes of Globigerina Limestone, detailed analyses were carried out. Globigerina Limestone samples obtained from stone types with two different known qualities were characterized according to petrographical, geochemical and physical properties. These included porosity, pore radii distribution and tensile strength, as well as water and humidity transport properties. Investigations by means of salt crystallization tests on quarry samples of both stone types reinforced the idea that the extent of salt weathering depends on salt type and concentration a

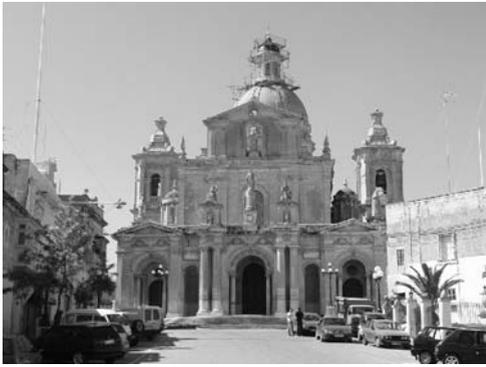
**Fig. 1.** The Baroque parish church of Siggiewi is one of numerous impressive Maltese buildings constructed from Globigerina Limestone.

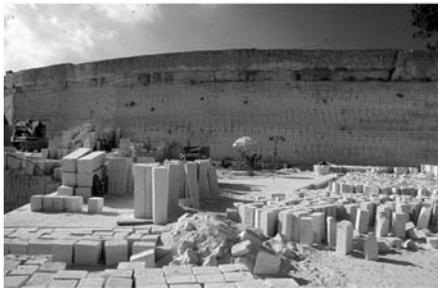
**Fig. 2.** (a) Modern buildings in Globigerina Limestone show that to this day this limestone is still one of the most important building materials in Malta. (b) This quarry, which is still active today, shows the extraction of Globigerina Limestone. The limestone blocks, here exposed to rain and sun for a short period, were previously left for much longer and led to a hardening of the stone surface.

Local stoneworkers distinguish macroscopically between two building stone qualities: 'Franka' and 'Soll'. Whereas 'Soll' represents *bad* quality building material, 'Franka' tends to resist the local environmental conditions well. In the fresh state, the two types cannot be distinguished visually, although a geochemical test and the pore-radii distribution may help to identify the two qualities (Farrugia 1993; Fitzner *et al.* 1996; Cassar 1999; Cassar & Vella 2003). In addition, on abandoned quarry faces 'Franka' and 'Soll' can be seen to differ in their weathering intensities. It can also be seen that in buildings, and occasionally in quarries, both types can sometimes coexist in the same horizontal layer, forming local areas with different geometries and shapes. As the weathering of the good-quality Globigerina Limestone leads to hardening of the stone surface, fresh quarry stones were in the past exposed to rain and sun for a long period before being utilized (Fig. 2b). This practice has been abandoned, primarily for economic reasons.

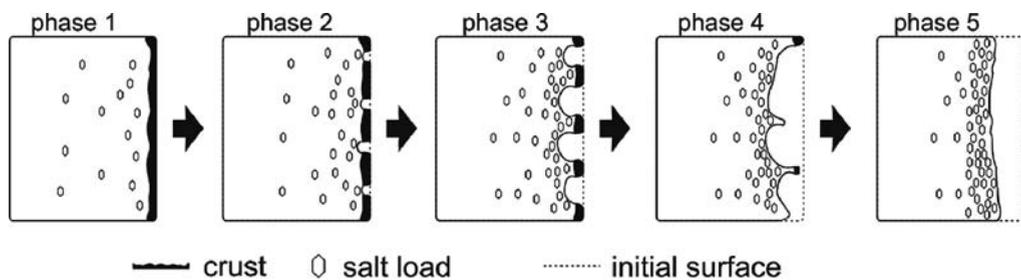
**Fig. 3.** Schematic representation of damage development, divided into five distinct phases (modified from Fitzner *et al.* 1996; explanation in text).

The original, non-weathered stone surface was one of the mapping forms identified. Following the damage model, at this stage of preservation, the formation of a superficial crust by re-precipitation of dissolved calcite can be seen to be taking place (phase 1, Fig. 3).

Slight-medium 'back-weathering' in the form of alveolar weathering was also observable. This is the mapped form called 'initial relief'. In this case, the stone surface is back-weathered through the formation of neighbouring cavities. Following the damage model by Vannucci *et al.* (1994) and Fitzner *et al.* (1996), this state represents damage phases 2 and 3 (both phases could not be distinguished on site). Local back-weathering with the formation of cavities can be traced back to cracking and/or partial loss of the crust owing to mechanical stress provoked by salt crystallization. Further accumulation of salt behind the crust leads to a detachment of the stone material in the form of granular disintegration and flaking within the cavities. The cause of the preferred back-weathering of the cavities is probably the increase of evaporation in areas where the crust has been lost.

The mapped form 'advanced relief' describes a weathering state where material loss and the formation of alveoli is very pronounced (phase 4 of the damage model). Also, connection of the

alveoli occurs. The septa of the honeycomb structure here are severely back-weathered, but are still recognizable.

The mapped form of ‘back-weathering’ represents the final deterioration state (phase 5 of the damage model) and follows after the ‘advanced relief’ weathering. The septa of the honeycombs are here totally back-weathered so that a more or less plain surface has developed and the edges of the blocks become rounded. Although back-weathering represents the final state of decay in the damage model, progressive material loss in form of flaking and granular disintegration is still subsequently observable on site.

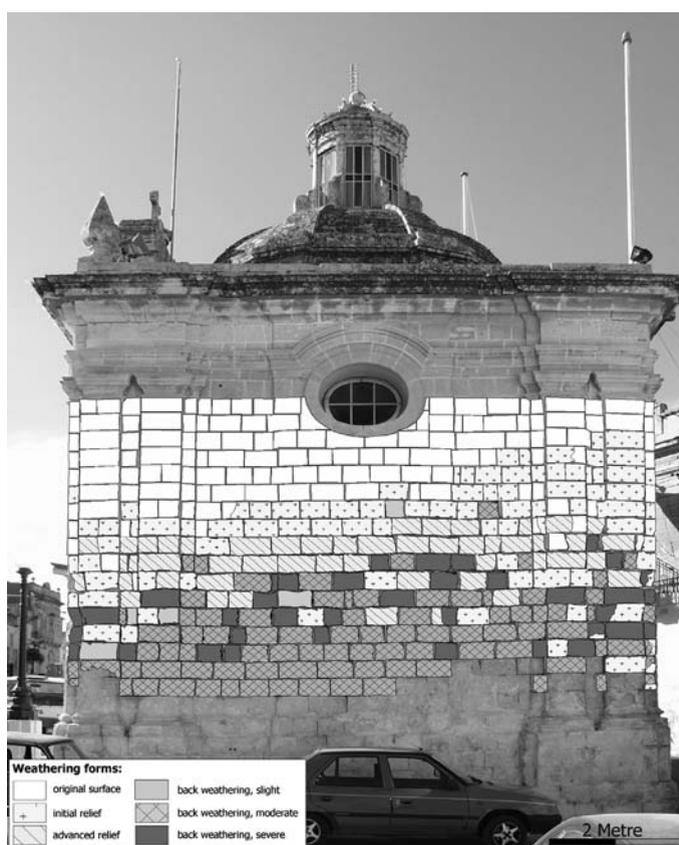
**Fig. 4.** Mapping of damage forms on the Church of Santa Marija Ta' Cwerra (south façade; 2004) reveals a clear distribution of weathering phenomena. Three zones in vertical order can be distinguished. Severe damage in the form of back-weathering occurs in the area immediately above the plastered lower courses. Further up, the middle zone is seen to have severe to moderate damage. Here alveolar weathering additionally affects numerous building stones. With the exception of a few building stones, the uppermost zone has remained in relatively good condition. These stones have developed a red–brown patina typical of good local building stone. There are, however, areas with organic deposition.

In Figure 4, the distribution of damage forms is shown for the south façade of the church. The uppermost part of this façade is characterized by

Very severe damage can be noticed in the lower parts of the walls, directly above the plastered lower courses (Fig. 4). In this part of the masonry

The intensity of stone loss evaluated during the mapping has been subdivided according to the estimated depth of the back-weathered surface, namely, slight (<3 cm), moderate (3–5 cm) and severe (>5 cm). Back-weathering of the whole stone surface can be observed on the lower part of the church, above the plastered lower courses. However, the comparison between the mappings from 1995 (Fitzner *et al.* 1995) and 2004 (Rothert 2004) showed that the weathering intensity had changed only slightly over the years.

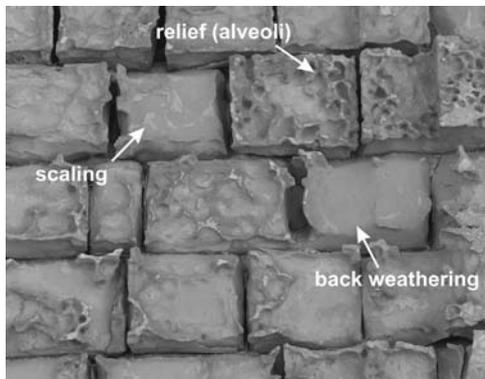
**Fig. 5.** Detachment and loss of stone material characteristic of the south façade. Relief in the form of alveoli and back-weathering by scaling are the prevalent weathering forms.

original and undamaged stone surfaces. However, in the lower parts of the wall the predominant damage phenomena are ‘relief’ and ‘back-weathering’ (Fig. 5). The middle part of the mapped façade is dominated by ‘initial’ and ‘advanced relief’ forms. Furthermore, a zoning of the relief forms can be observed. ‘Advanced relief’ is characterized by irregular back-weathered stone surfaces, mainly located in the lower middle part, while ‘initial relief’ development is observed in the upper middle part. Material loss in the areas where both relief forms occur is characterized by granular disintegration and crumbling in the cavities.

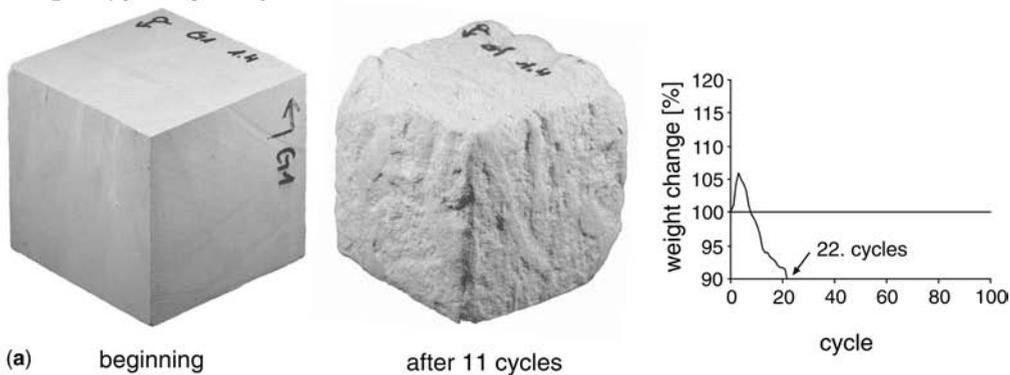
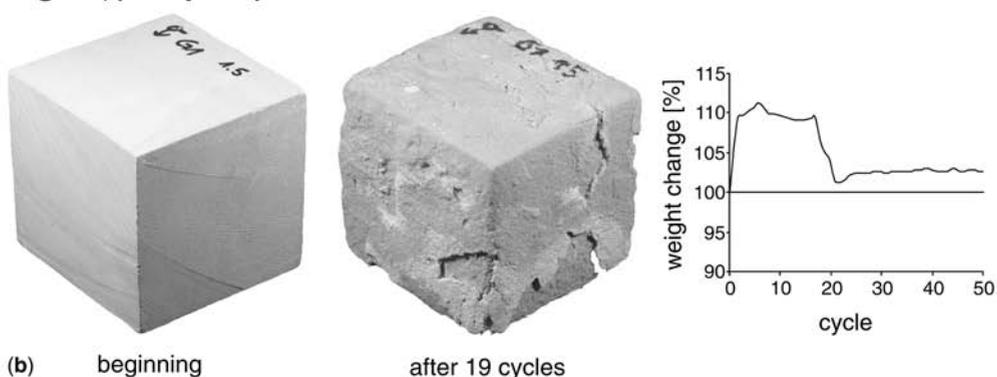
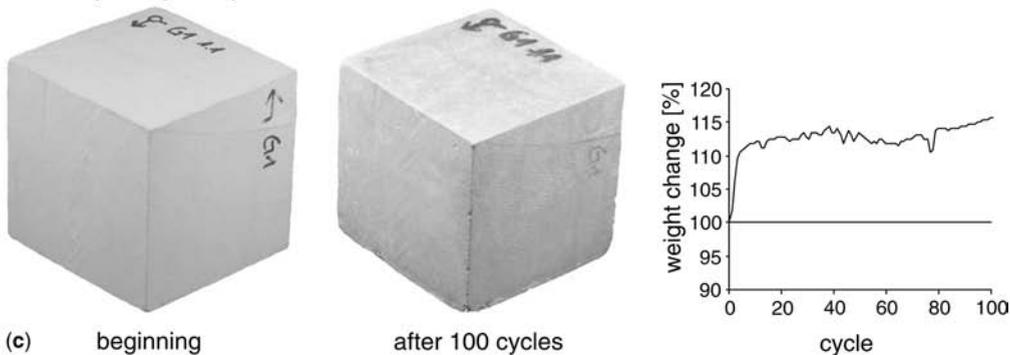
**Fig. 6.** Results of the salt-loading tests. (a) Samples that have undergone the sodium sulphate test, at the beginning, and showing definite deterioration after 11 cycles of artificial weathering. (c) Largely unchanged sample that has undergone the sodium chloride test, at the beginning, and after 100 cycles. On the right-hand side, the respective change in weight is plotted against the number of loading cycles.

second cycle. For the samples seen in Figure 6a, back-weathering is most pronounced parallel to pre-existing sedimentary structures, evident after the sixth cycle. The tests were discontinued after a

loss in weight of 10%. The overall result was that the stone cubes of Type II resisted 22 or 24 such cycles, whereas the Type I cubes behaved differently. Here, for one sample, the critical weight loss was achieved after 17 cycles, while for another sample this happened after 51 cycles. This indicates that the latter samples were probably more heterogeneous.

The salt-loading tests with magnesium sulphate demonstrated that the Globigerina Limestone also showed a slight granular disintegration at the edges and the surfaces after the second weathering cycle. After the ninth cycle and again after the 19th cycle, an obvious scaling effect occurred (Fig. 6b). A total of 50 salt-weathering cycles were performed, although after the 25th cycle no further macroscopic changes occurred. The changes in weight were at a maximum after the sixth cycle (where an 11% increase in weight was registered), which means that the samples retained a large amount of the  $MgSO_4$ . After the breakaway of the scales, a decisive weight loss was ascertained.

In contrast, the samples loaded with sodium chloride were only slightly affected, even after 100 test cycles (Fig. 6c). For both investigated stone types an increase in weight was observable, which is again the consequence of salt enrichment. Only slight granular disintegration occurred at the edges of these specimens. Thus, the damage caused by sodium chloride was only slight when compared to the effects of sodium sulphate.
