Limestone weathering on historical monuments in Cairo, Egypt

BERND FITZNER, KURT HEINRICHS & DENNIS LA BOUCHARDIERE

Abstract: Since Pharaonic times local limestones have been used in Cairo for monument construction. Weathering damage on many historical stone monuments in Cairo is alarming. Studies on properties and weathering behaviour of the limestones were carried out by means of laboratory tests and in situ investigation of many historical monuments. The laboratory studies reveal for the Middle Eocene limestones considerable petrographical variations. The limestone weathering was assessed with respect to weathering forms, weathering products and weathering profiles. A classification scheme of weathering forms and their intensities was tailored to optimal applicability for all Cairo historical monuments constructed from limestones. Monument mapping has been applied for the detailed registration of weathering forms and as a basis for the quantitative rating of stone damage by means of damage categories and damage indices. For the historical monuments in the centre of Cairo the combined evaluation of weathering forms, weathering products and weathering profiles shows clear correl

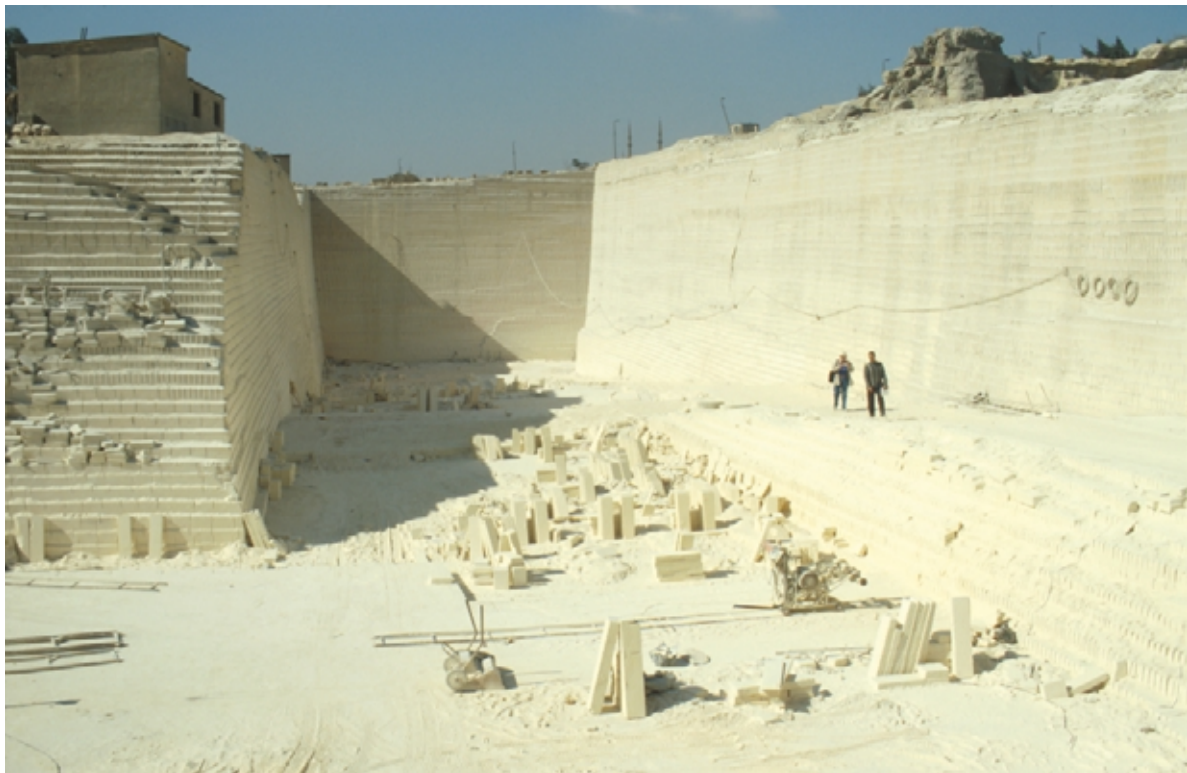
Fig. 3. Limestone quarry, Mokattam mountains west of Cairo city.

Tertiary porous limestones from local quarries have been used for construction of monuments in Cairo since Pharaonic times until today (Fig. 3). In monument preservation practice the limestones are still used for stone replacement or rebuilding works at Cairo historical monuments. Porous limestones represent a stone type that was commonly used for the construction of historical monuments in the whole Mediterranean area.

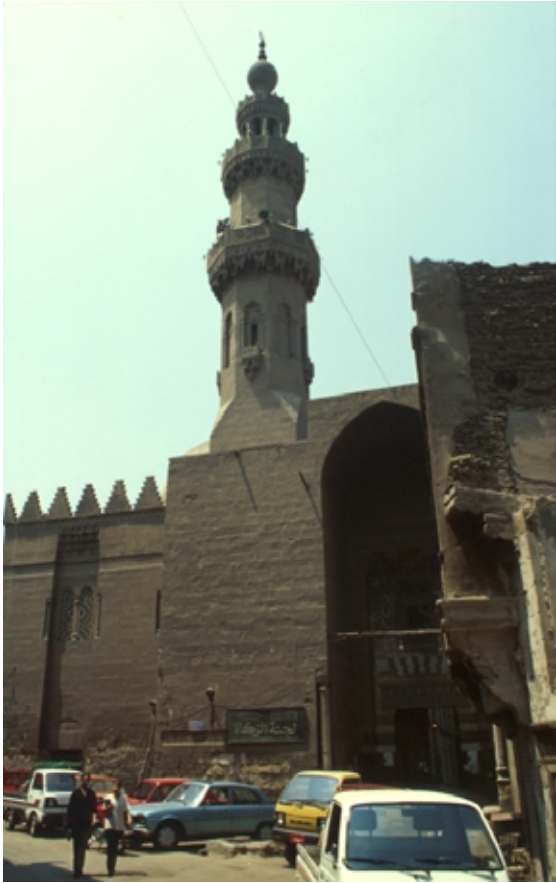
Fig. 4. El-Merdani Mosque.

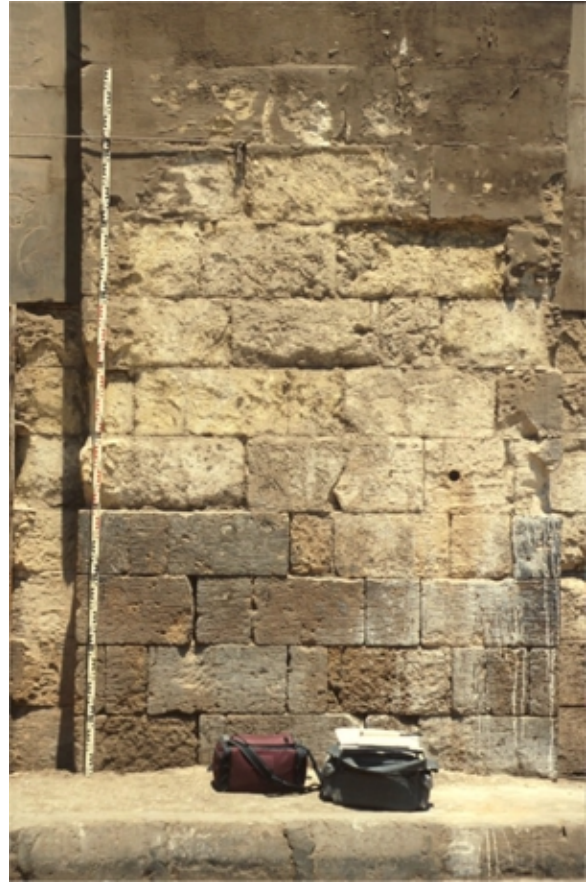
Fig. 5. Weathering damage on a lower part of the El-Merdani Mosque.

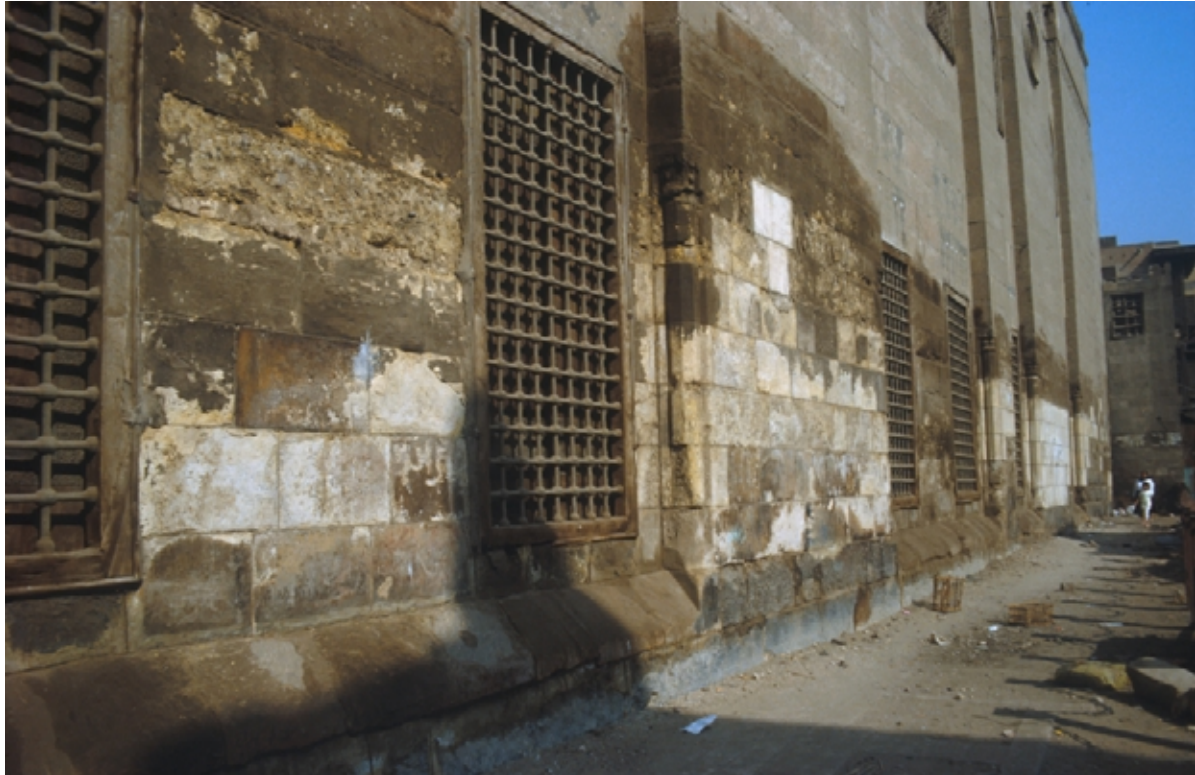
Fig. 6. Weathering damage. Mausoleum of Sultan Al-Mansur Qalawun.

Many historical limestone monuments in the Cairo area are seriously threatened by damage and are in need of intervention. Stone weathering represents an important cause of damage. Systematic studies were carried out for the petrographical characterization of the limestones and for the analysis of their weathering behaviour. These studies comprised laboratory analyses of the limestones and in situ investigation of quarries and Islamic monuments and, additionally, pilot studies of the Giza pyramids. The in situ investigation included survey, classification and mapping of weathering forms and in situ measurements. Very detailed studies were carried out on the El-Merdani Mosque in the frame of the Concerted Action 'Study, characterization and analysis of degradation phenomena of ancient, traditional and improved building materials of geologic origin used in the construction of historical monuments in the Mediterranean area' (ERB-IC18-CT98-0384), funded by the European Commission. The El-Merdani Mosque in the quarter of Tabbana was built in the 14th century as one of the finest examples of Islamic architecture in Cairo (Fig. 4). The mosque was restored a century ago by the Arab Antiquities Conservation Committee (Williams 1993). Preservation measures such as reconstruction, structural reinforcement and renovation of walls were carried out, but today the mosque is again in need of intervention. Especially, the considerable weathering damage on the lower parts of the monument is striking (Fig. 5). This state of damage is very characteristic for many Islamic monuments in the centre of Cairo (Fig. 6 and 7).

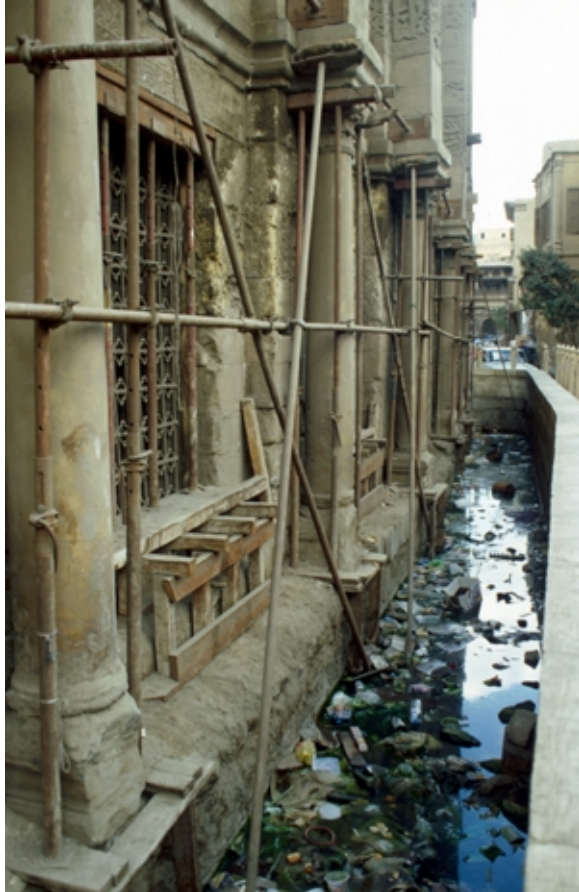
Fig. 7. Weathering damage and elevated water table. Mausoleum of Sultan Al-Mansur Qalawun.

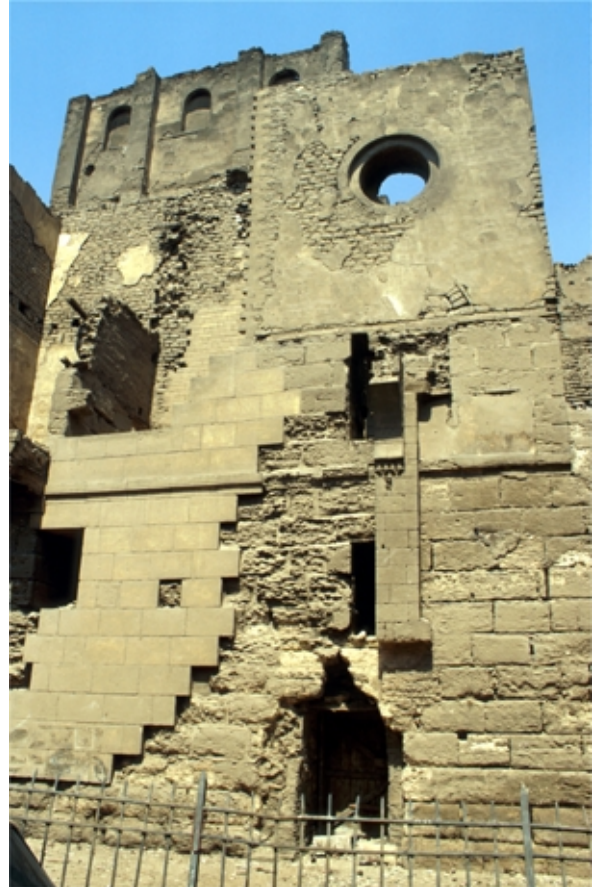
Fig. 8. Stone replacement. Hospital of Sultan Al-Mansur Qalawun.

Eocene outcrops in the area of Greater Cairo predominantly provided the limestones for the construction of the historical stone monuments in this region. Especially, these were the Mokattam limestone plateau east of Cairo city, the Helwan limestone plateau in the southeast and the Giza limestone plateau in the western part of Greater Cairo (Fig. 1). The pyramids mainly were constructed from local Giza limestones. Limestones from the Mokattam area were used additionally, like for the facing dimension stones of the Great Pyramid of Cheops (Khufu), only few of which have remained (Klemm & Klemm 1993). In the Mokattam area and in the Helwan area limestones were quarried for the historical monuments in Cairo city. They are still being used for stone replacement or rebuilding works at these monuments as well as for modern buildings (Fig. 8 and 9).

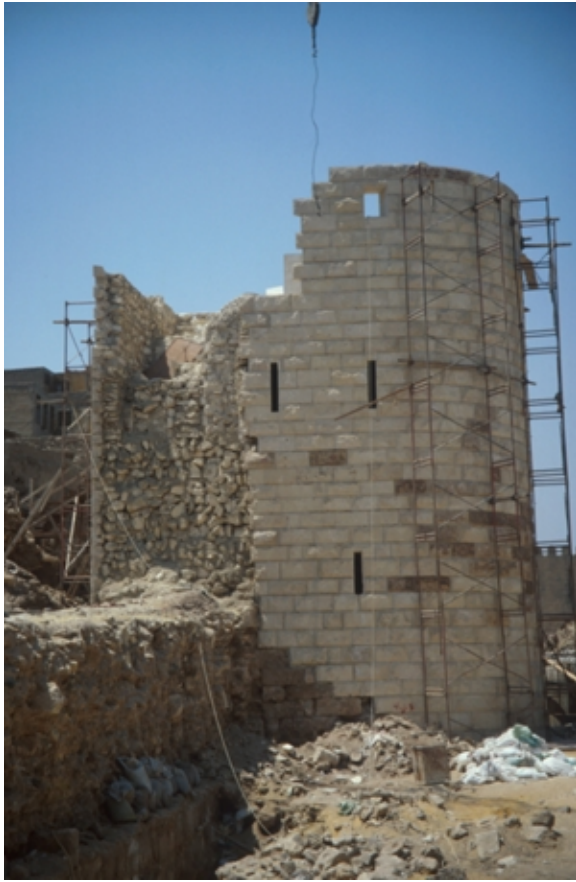
Fig. 9. Restoration works. Northern wall of Cairo.

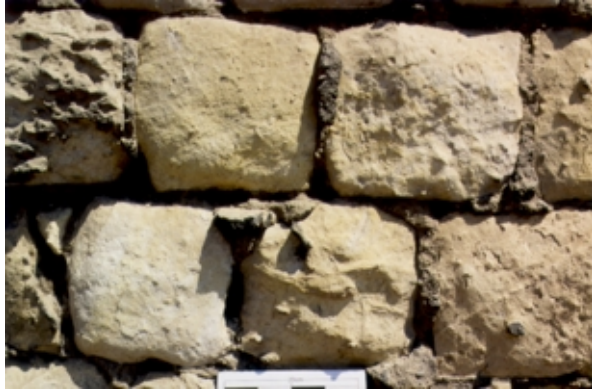
Fig. 11. Weathering form 'relief (R)'. Image width appr. 90 cm.

A section of the classification scheme summarizing the frequent weathering forms observed on the limestone monuments in Cairo is presented in Table 3. Examples of weathering forms are shown in Fig. 11-15. Examples of the intensity classification of weathering forms developed for the Cairo limestone monuments are presented in Table 4. The intensity classification has been differentiated for limestone monuments composed of small- to medium-sized dimension stones (Table 4, intensity classification A) and limestone monuments composed of huge dimension stones (Table 4, intensity classification B) considering the different ranges of intensities.

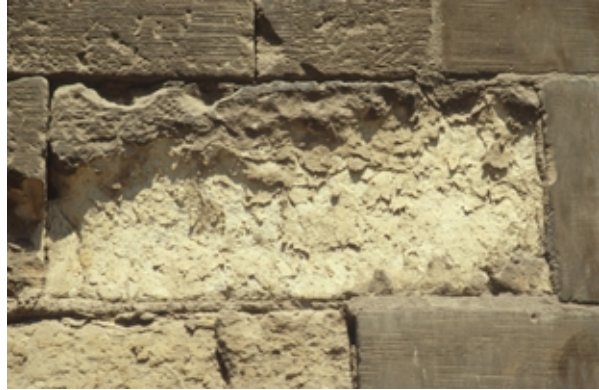
Fig. 12. Weathering forms 'back weathering (W)', 'crust (C)' and 'flaking (F)'. Image width appr. 70 cm.

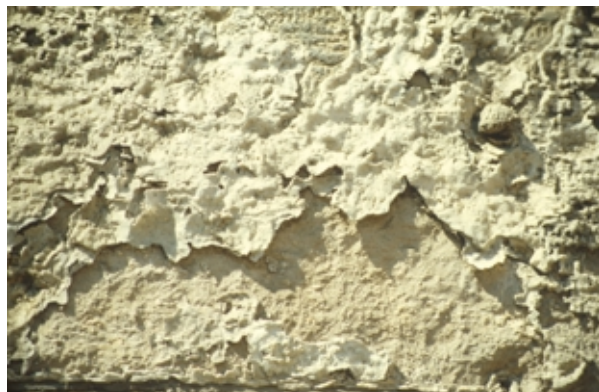
Fig. 14. Weathering forms 'back weathering (W)', 'crust (C)', 'detachment of crusts with stone material (K)' and 'granular disintegration (G)'. Image width appr. 30 cm.

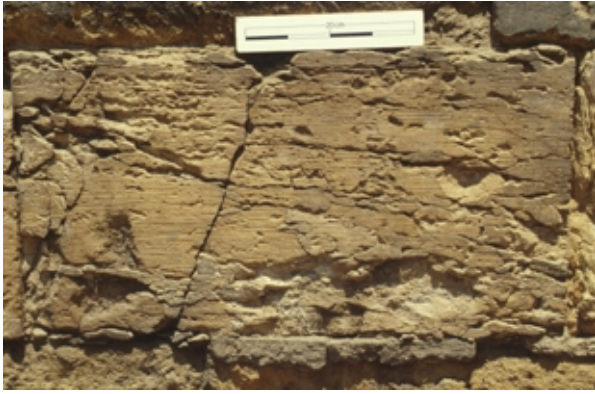
Fig. 15. Weathering forms ‘relief (R)’, ‘break out (O)’, ‘crumbly disintegration (P)’ and fissures (L)’. Image width appr. 70 cm.

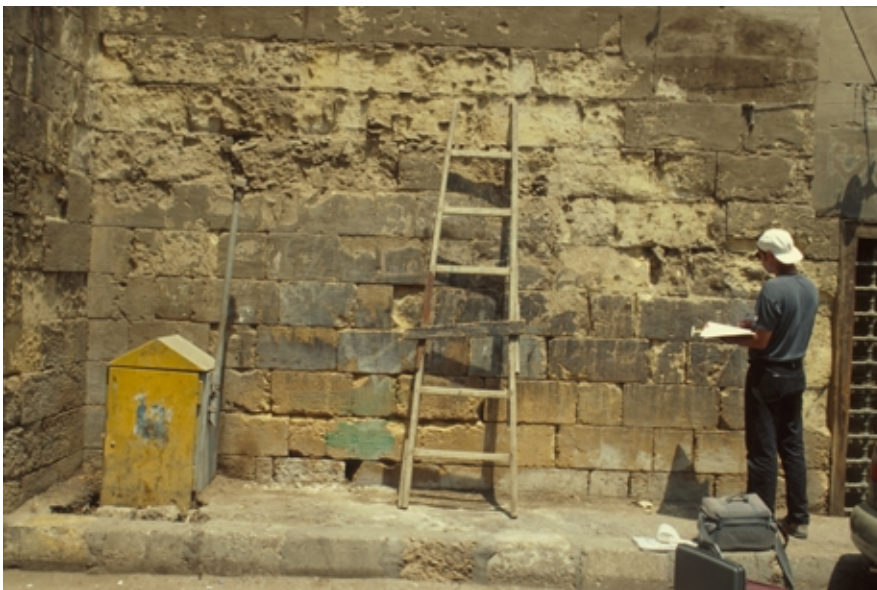
Fig. 16. El-Merdani Mosque - lower part of the SE-façade.

While weathering forms allow the detailed, objective and reproducible description and mapping of stone deterioration phenomena, damage categories and damage indices were integrated into the monument mapping method as tools for the rating of stone damage (Fitzner et al. in press, Fitzner & Heinrichs in press, Heinrichs & Fitzner 1999). For the rating of individual stone damage, six damage categories were defined: 0 – no visible damage, 1 – very slight damage, 2 – slight damage, 3 – moderate damage, 4 – severe damage, 5 – very severe damage. A correlation scheme of weathering forms and damage categories was developed for the limestone monuments in Cairo considering the high historical and artistical value of these monuments. In this correlation scheme, damage categories were proposed for all weathering forms in dependence upon their intensities. A section of this correlation scheme is shown in Table 5. The correlation scheme of weathering forms and damage categories was differentiated for limestone monuments composed of small to medium dimension stones and limestone monuments composed of huge dimension stones considering the different intensity ranges of several weathering forms. Based on the correlation scheme, damage categories were derived for all weathering forms and their combinations registered by means of monument mapping. The damage categories were illustrated in maps and were evaluated quantitatively. Maps of damage categories are shown for parts of the El-Merdani Mosque (Fig. 18) and the Great Pyramid of Cheops (Fig. 19-21) as examples.

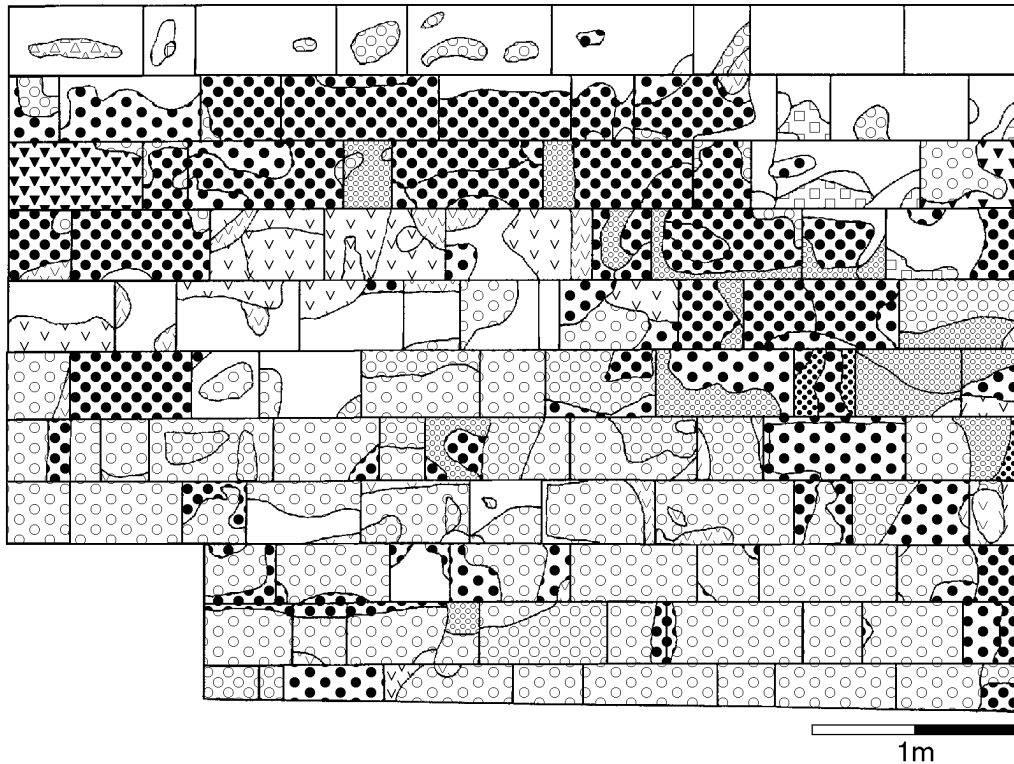
Back weathering (W)	Intensities according to depth d of back weathering (cm)						
	Intensity 1 $d \leq 0.2$	Intensity 2 $0.2 < d \leq 0.5$	Intensity 3 $0.5 < d \leq 1$	Intensity 4 $1 < d \leq 3$	Intensity 5 $3 < d \leq 5$	Intensity 6 $5 < d \leq 10$	Intensity 7 $d > 10$
sW							
cW							
zW

Relief (R)	Intensities according to depth d of relief (cm)						
	Intensity 1 $d \leq 0.2$	Intensity 2 $0.2 < d \leq 0.5$	Intensity 3 $0.5 < d \leq 1$	Intensity 4 $1 < d \leq 3$	Intensity 5 $3 < d \leq 5$	Intensity 6 $5 < d \leq 10$	Intensity 7 $d > 10$
Ro

Break out (O)	Intensities according to volume v of break out (dm ³)				
	Intensity 1 $v \leq 0.01$	Intensity 2 $0.01 < v \leq 0.125$	Intensity 3 $0.125 < v \leq 0.5$	Intensity 4 $0.5 < v \leq 1$	Intensity 5 $v > 1$
oO

Fig. 17. Map of weathering forms. Group 1 of weathering forms, ‘loss of stone material’. El-Merdani Mosque, lower part of the SE-façade.

sustainable monument preservation (Fitzner, Heinrichs & Kownazki 1995 and 1997). As an example for the computer-enhanced illustration of weathering forms registered by monument mapping the map of all weathering forms of group 1 – ‘loss of stone material’ is shown for a lower masonry part of the El-Merdani Mosque (Fig. 16 and 17). In the same way maps were prepared for all stone surfaces of monuments that were studied in Cairo showing the weathering forms of group 2 – ‘discoloration / deposits’, group 3 – ‘detachment’ and group 4 – ‘fissures / deformation’. All weathering forms and their combinations were evaluated quantitatively.

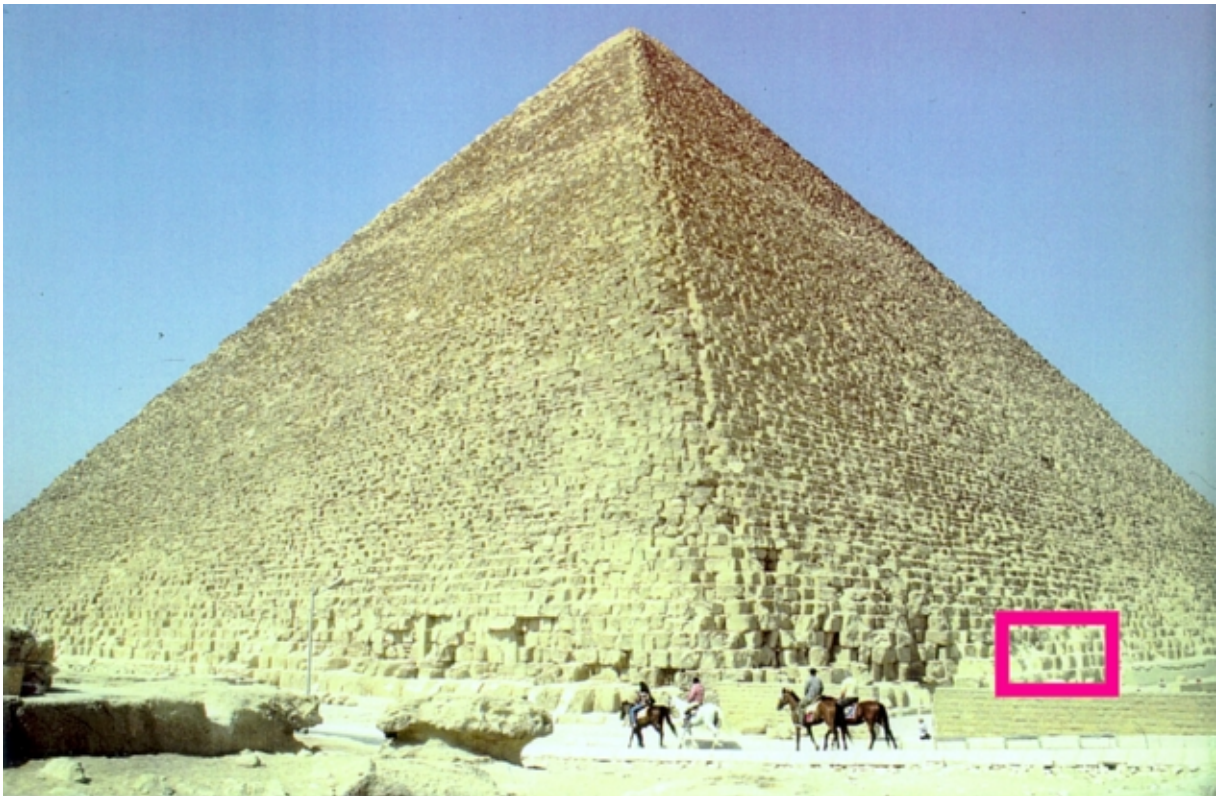
Fig. 19. Great Pyramid of Cheops, Giza (investigation area marked).

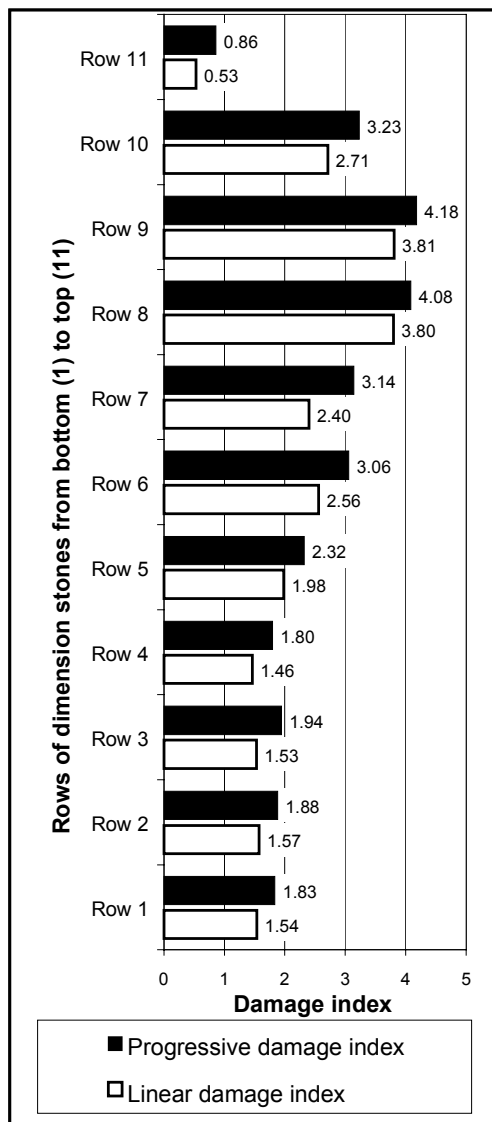
Fig. 23. Damage indices according to rows of dimension stones. El-Merdani Mosque, lower part of the SE-façade.

In order to quantify this zonation of stone damage, damage indices were calculated individually for rows of dimension stones (Fig. 23). Maximum damage indices - DI_{lin} up to 4.2, DI_{prog} up to 4.3 - were found at a height in the range between 2.0 and 2.5 m above ground level. It is striking that at El-Merdani Mosque and many other monuments, this zonation of stone damage can superpose the heterogeneous distribution of different limestone varieties in the walls of the monuments.

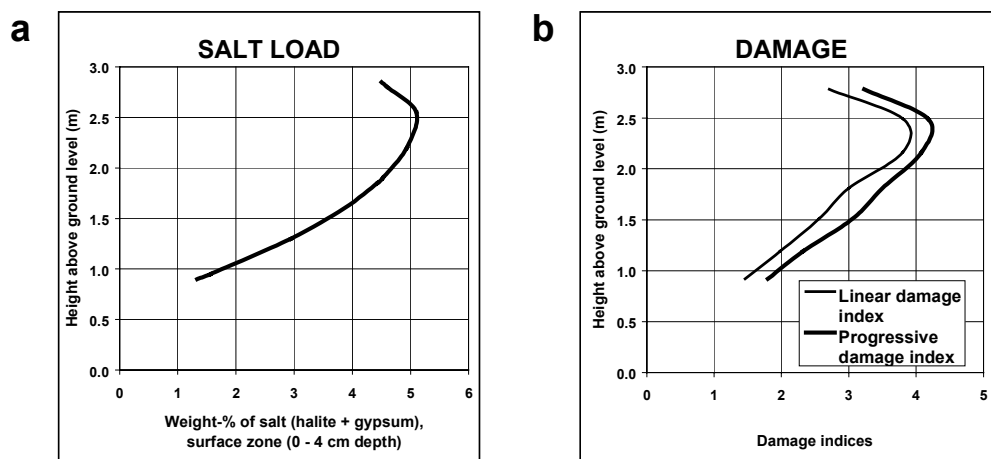
Fig. 27. Correlation between salt load (a) and stone damage (b) across a vertical profile. El-Merdani Mosque, lower part of the SE-façade.

vertical weathering profiles have proved the clear correlation between salt loading of the limestones and their state of damage (Fig. 27). It can be seen that stone damage increases as salt load increases.

Regarding the lower parts of monuments in the centre of Cairo, most severe stone damage was found at those zones of the walls which correspond to the main level of salt precipitation from rising humidity. A clear correlation between extent of salt loading and degree of stone damage - following a vertical profile - was shown for such lower parts of Cairo monuments.
